RICS **Building Survey**

Property address
Clients name
Date of inspection 08 September 2017
Insurance reinstatement costs £503,000.00

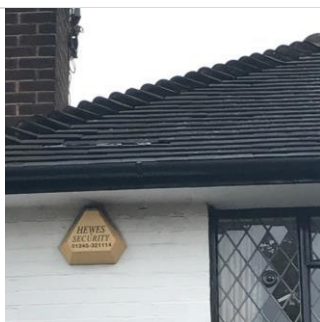
There are broken/misplaced roof tiles. The roof would benefit from being overhauled.

Cost of associated remedial work detailed in Section C, R2.

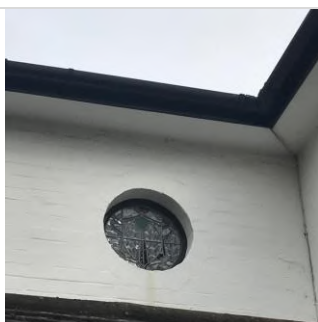
There is evidence of a leaking gutter to the front.

Cost of associated remedial work detailed in Section C, R6.

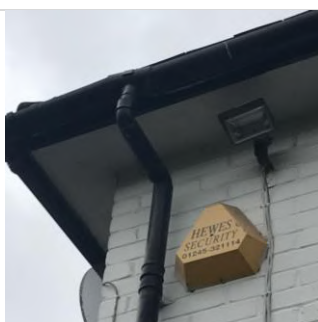
There is evidence of a leaking gutter to the rear.

Cost of associated remedial work detailed in Section C, R10.

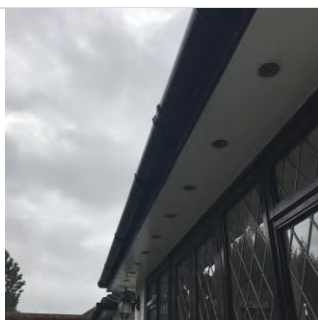
There is evidence of a leaking gutter to the rear.

Cost of associated remedial work detailed in Section C, R11.

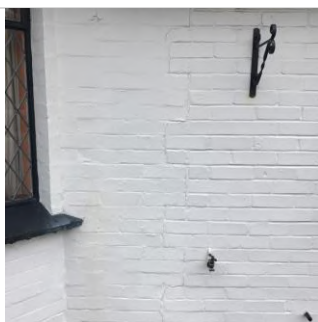
There is evidence of movement in the form of stepped cracks to the front elevation however, this does not appear to be progressive and we believe this to be historical.

Where there is evidence of previous movement to the property, it would be prudent to maintain the existing insurance cover to ensure there is continuity in the event of any future claim.

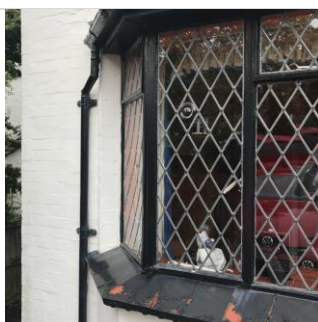
Although functional, the windows are generally at the end of their life cycle and would benefit from full replacement.

Cost of associated remedial work detailed in Section C, R5.

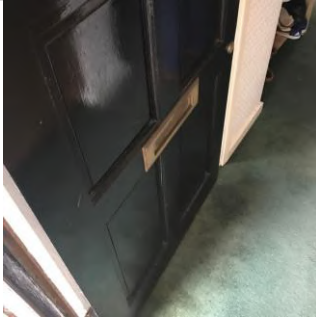
Although functional, the door is generally at the end of its life cycle and would benefit from full replacement.

Cost of associated remedial work detailed in Section C, R13.

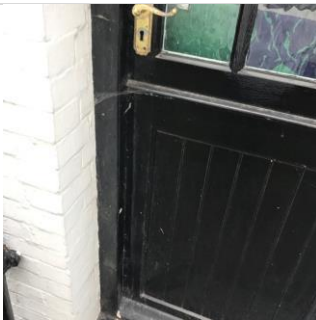
Although functional, the door is generally at the end of its life cycle and would benefit from full replacement.

Cost of associated remedial work detailed in Section C, R12.

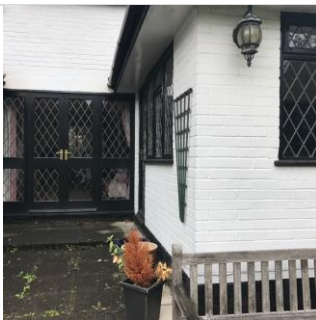
Although functional, the two sets of French doors are generally at the end of their life cycle and would benefit from full replacement.

Cost of associated remedial work detailed in Section C, R9.

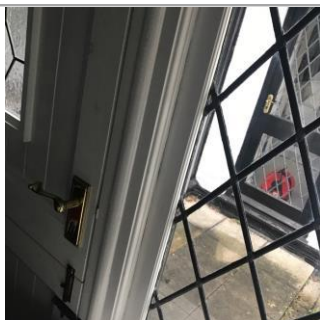
Although functional, both doors are generally at the end of their life cycle and would benefit from full replacement.

Cost of associated remedial work detailed in Section C, R33.

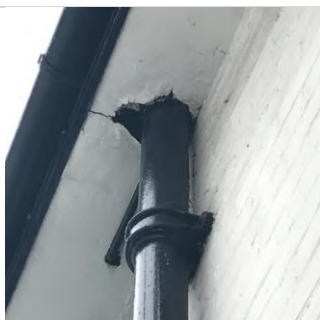
There is a damaged soffit that will need to be replaced.

Cost of associated remedial work detailed in Section C, R4.

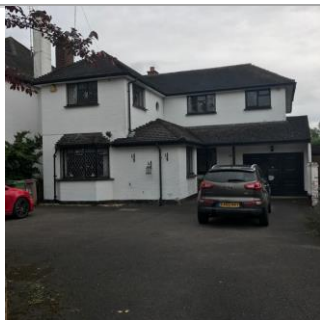
External decorations are starting to deteriorate and would benefit from re-decoration.

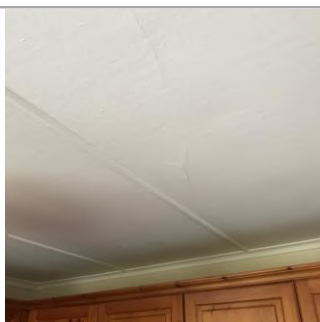
The ceiling is not secure to the ceiling joists and we recommend it be replaced.

Cost of associated remedial work detailed in Section C, R19.

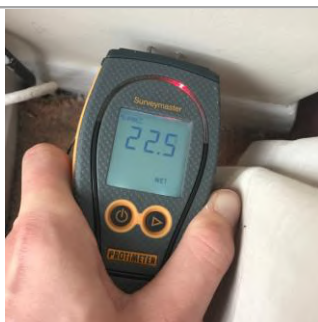
Tests carried out to the external wall with a damp meter revealed readings as per the attached photograph.

A reading above 20% WME (wood moisture equivalent) is a cause for concern and is caused by rising damp. This will require a chemical damp proof course injection. Note: there may be further defects including wet rot under the floor as a result of the damp and further investigation is recommended.

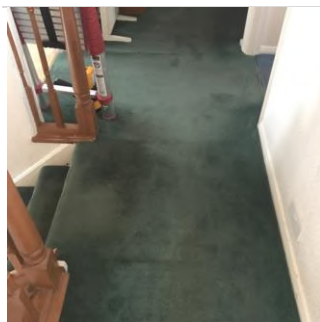
Landing

The floor would benefit from having the floorboards secured once floor coverings have been removed as there are loose floorboards resulting in creaking floors. This may simply be the result of poor workmanship.

Cost of associated remedial work detailed in Section C, R17.

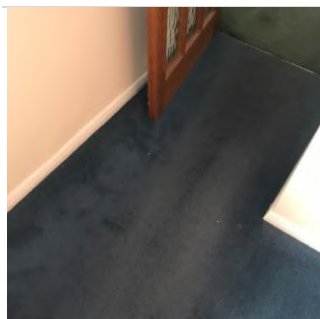
Master Bedroom

Further investigation is recommended due to the floor not being flat. This may simply be the result of poor workmanship.

Cost of associated remedial work detailed in Section C, R20.

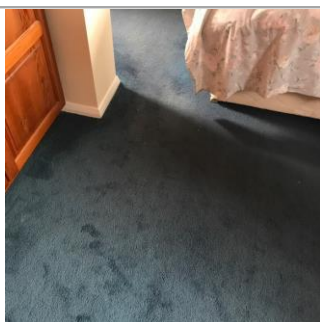
The floor would benefit from having the floorboards secured once floor coverings have been removed as there are loose floorboards resulting in creaking floors. This may simply be the result of poor workmanship.

Cost of associated remedial work detailed in Section C, R23.

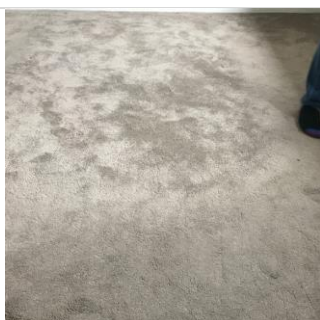
Bedroom 3

The floor would benefit from having the floorboards secured once floor coverings have been removed as there are loose floorboards resulting in creaking floors. This may simply be the result of poor workmanship.

Cost of associated remedial work detailed in Section C, R26.

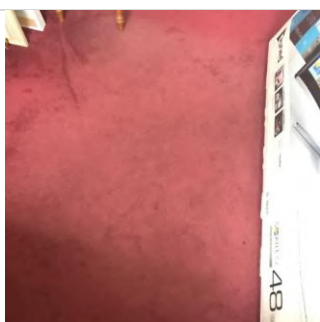
Bedroom 4

The floor would benefit from having the floorboards secured once floor coverings have been removed as there are loose floorboards resulting in creaking floors. This may simply be the result of poor workmanship.

Cost of associated remedial work detailed in Section C, R28.

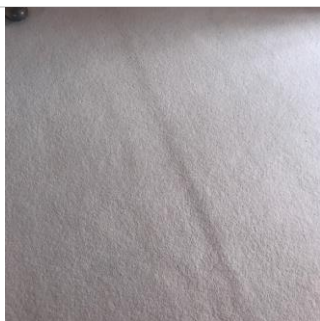
Living Room 1

Further investigation is recommended due to the floor not being flat. This may simply be the result of poor workmanship.

Cost of associated remedial work detailed in Section C, R34.

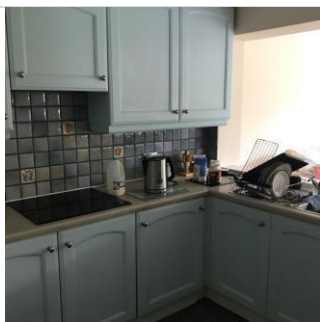
The kitchen units and components in general are showing wear and tear, but are functional.

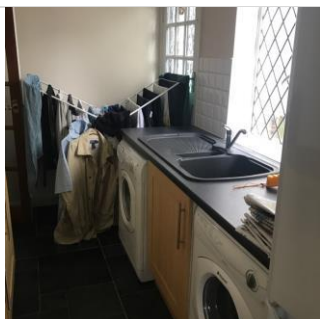
Utility

The utility units and components in general are showing wear and tear, but are functional.

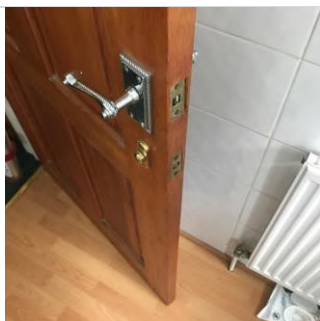
Bathroom

Faulty door furniture

Cost of associated remedial work detailed in Section C, R15.

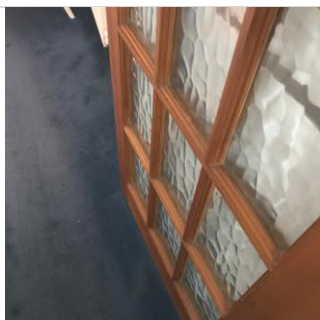
Master Bedroom

Glazed doors are considered unsafe, especially with young children.

Cost of associated remedial work detailed in Section C, R18.

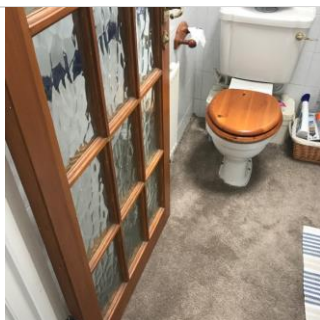
En Suite

Glazed doors are considered unsafe, especially with young children.

Cost of associated remedial work detailed in Section C, R21.

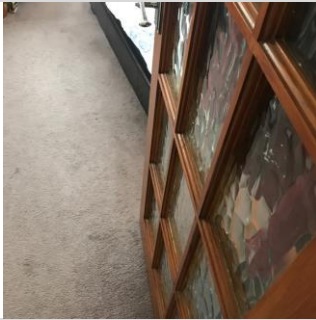
Bedroom 2

Glazed doors are considered unsafe, especially with young children.

Cost of associated remedial work detailed in Section C, R24.

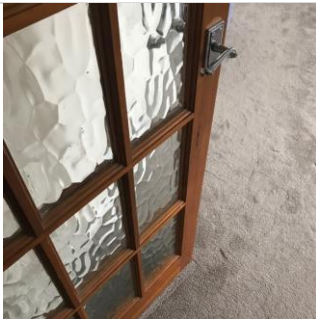
Bedroom 3

Glazed doors are considered unsafe, especially with young children.

Cost of associated remedial work detailed in Section C, R25.

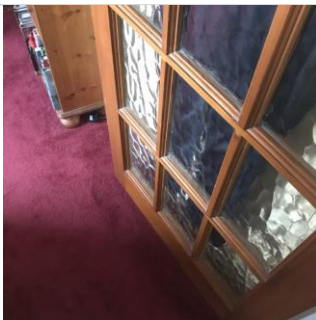
Bedroom 4

Glazed doors are considered unsafe, especially with young children.

Cost of associated remedial work detailed in Section C, R27.

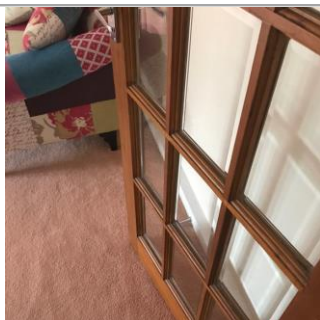
Glazed doors are considered unsafe, especially with young children.

Cost of associated remedial work detailed in Section C, R29.

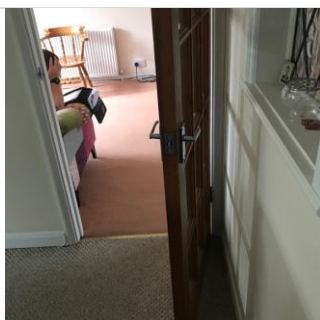
Kitchen

Glazed doors are considered unsafe, especially with young children.

Cost of associated remedial work detailed in Section C, R30.

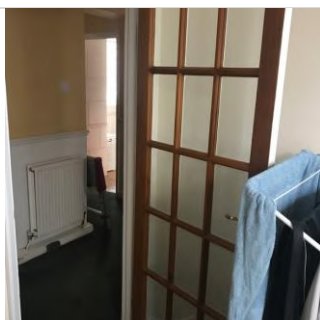
Utility

Glazed doors are considered unsafe, especially with young children.

Cost of associated remedial work detailed in Section C, R31.

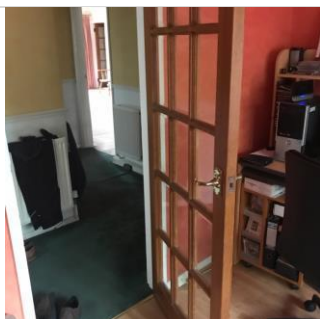
Living Room 3

Glazed doors are considered unsafe, especially with young children.

Cost of associated remedial work detailed in Section C, R32.

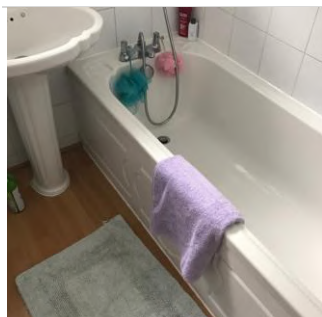
The bathroom fittings and components in general are showing wear and tear, but are functional.

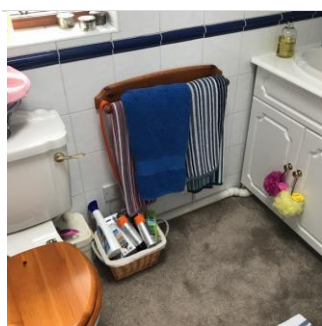
This En Suite would benefit from complete refurbishment. The Saniflo macerator was leaking.

Cost of associated remedial work detailed in Section C, R22.

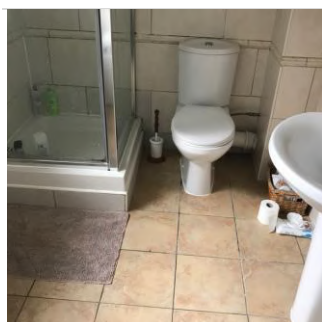
The shower room fittings and components in general are showing wear and tear, but are functional.

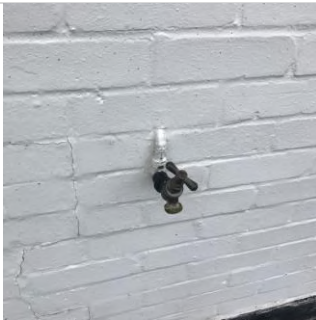
There is no insulation to the outside tap on the front elevation. This needs to be insulated to protect the tap from freezing.

Cost of associated remedial work detailed in Section C, R3.

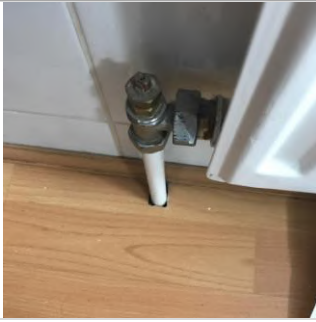
The radiator has one missing radiator valve cover.

Cost of associated remedial work detailed in Section C, R16.

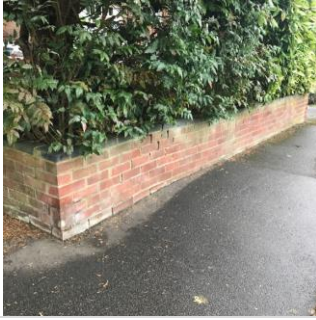
The boundary/retaining wall is loose and needs to be re-built.

Cost of associated remedial work detailed in Section C, R1.

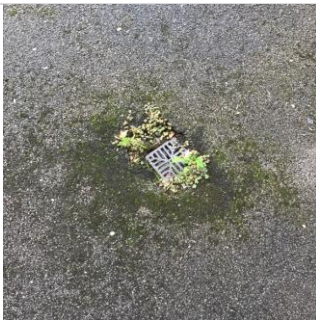
The macadam has sunk around drain.

Cost of associated remedial work detailed in Section C, R7.

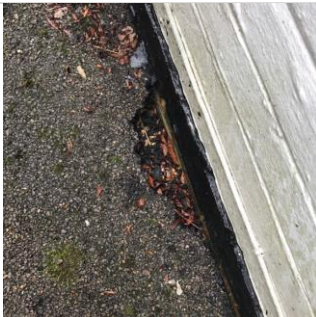
Defective macadam.

Cost of associated remedial work detailed in Section C, R8.
