RICS  
**Building Survey** ●●●

Property address  
Clients name  
Date of inspection 27 July 2017  
Market valuation £747,000.00  
Insurance reinstatement costs £445,000.00

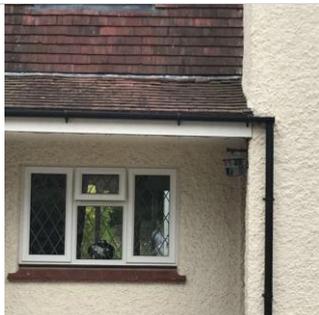
There are broken/misplaced roof tiles. The canopy roof would benefit from being overhauled.

R10	Overhaul tile roof, re-fix loose tiles, renew tiles to match existing, redress, re-wedge, repoint all flashings, aprons, chimney, gutters etc., renew fillets with lead flashings, repoint ridges etc.		£300.00
R11	Allow for external decorations.		£2,000.00
R12	Allow to replace rotting fascia to garage.		£500.00
R13	Allow to remove timber store shed.		£200.00
R14	Allow to ease and adjust internal door including removing, lubricating and refitting of doors, refitting door stop or replacing, furniture or replacing for new and making good holes where necessary to frames and doors.		£100.00
R15	Supply and fix uPVC windows comprising frame, sill, mullions and transom filled in with any number of fixed or opening lights complete with beads and/or gaskets as applicable and all necessary cover mouldings trims and window boards, beading and ironmongery and bedding and/or pointing in mastic and glazing with double glazed units and making good all work disturbed including removing and		£2,000.00

Cost of associated remedial work detailed in Section C, R10.

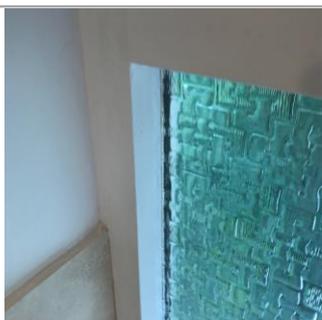
The single-glazed timber window is generally at the end of its life cycle and would benefit from full replacement.

We recommend the double-glazed timber window also be replaced to uPVC to match the other existing uPVC windows.

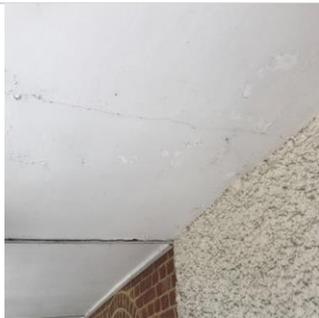
External decorations are starting to deteriorate and would benefit from re-decoration.

Cost of associated remedial work detailed in Section C, R11.

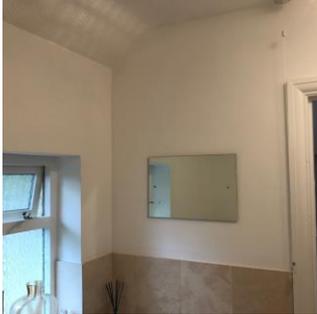
### En Suite

There is blown plaster that would benefit from being re-plastered.

Cost of associated remedial work detailed in Section C, R3.

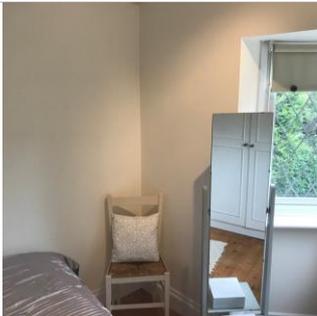
### Bedroom 3

There is blown plaster that would benefit from being re-plastered.

Cost of associated remedial work detailed in Section C, R4.

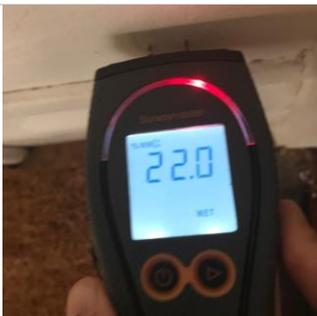
### Hall

Tests carried out to the external wall with a damp meter revealed readings as per the attached photograph.

A reading above 20% WME (wood moisture equivalent) is a cause for concern and is caused by rising damp. This will require a chemical damp proof course injection. Note: there may be further defects including wet rot under the floor as a result of the damp and further investigation is recommended.

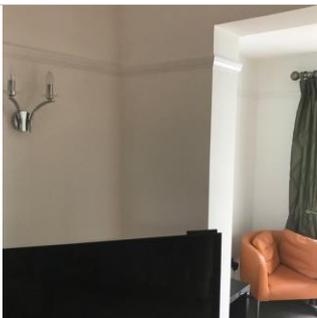
### Living Room 2

There is blown plaster that would benefit from being re-plastered.

Cost of associated remedial work detailed in Section C, R5.

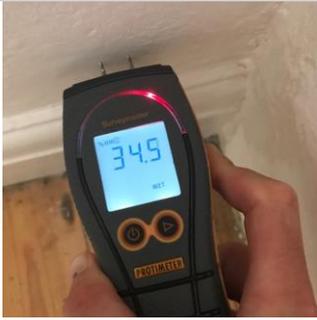
Tests carried out to the side external wall with a damp meter revealed readings as per the attached photograph.

A reading above 20% WME (wood moisture equivalent) is a cause for concern and is caused by rising damp. This will require a chemical damp proof course injection. Note: there may be further defects including wet rot under the floor as a result of the damp and further investigation is recommended.

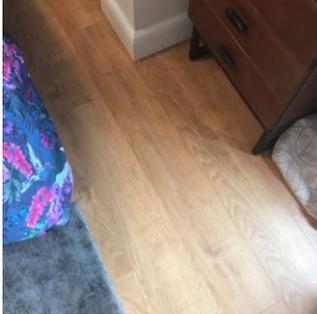
### Master Bedroom

Further investigation is recommended due to the floor not being flat. This may simply be the result of poor workmanship.

Cost of associated remedial work detailed in Section C, R2.

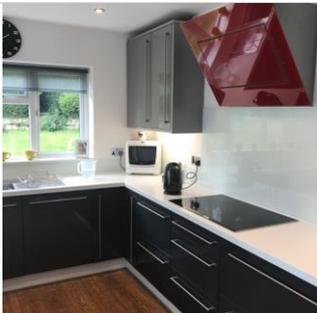
The kitchen units and components in general are showing wear and tear, but are functional.

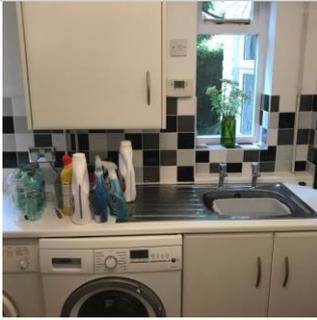
The utility units and components in general are showing wear and tear, but are functional.

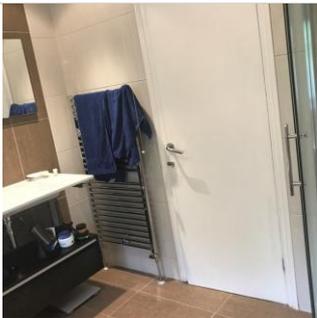
### Bathroom

The door does not close correctly and needs to be eased and adjusted.

Cost of associated remedial work detailed in Section C, R1.

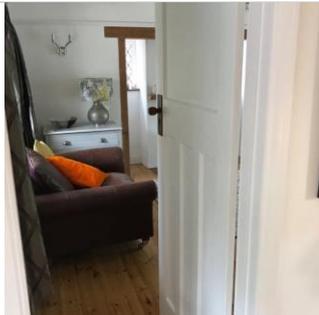
### Living Room 2

The door does not close correctly and needs to be eased and adjusted.

Cost of associated remedial work detailed in Section C, R14.

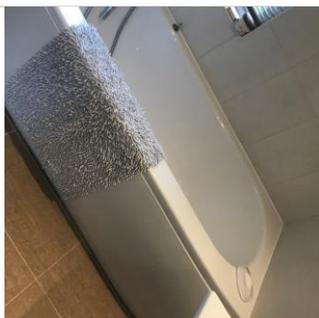
### Bathroom

The bathroom fittings and components in general are showing wear and tear, but are functional.

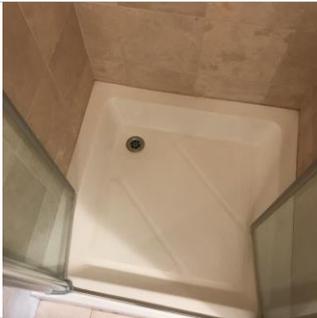
### En Suite

The En Suite fittings and components in general are showing wear and tear, but are functional.

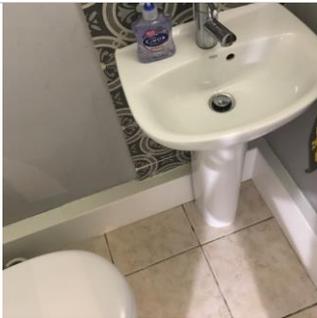
### Separate Toilet

The WC fittings and components in general are showing wear and tear, but are functional.

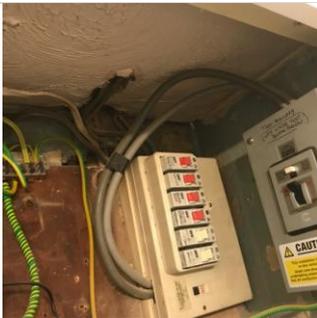
G1  
Electricity

There is a mains supply and the electricity was on when we inspected. The consumer board is located in the utility room. The consumer unit is a relatively old unit with old style electric fuses. 2

We recommend a full rewire be carried out to this property.

Cost of associated remedial work detailed in Section C, R17.

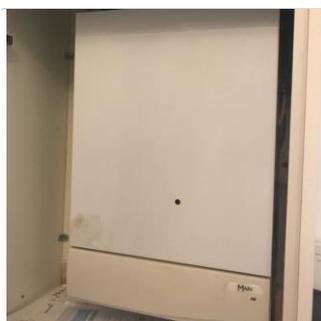
The boiler is at the end of its efficient lifespan and you may wish to consider replacing it with a modern appliance.

We recommend a new heating and hot water system for this property.

Cost of associated remedial work detailed in Section C, R16.

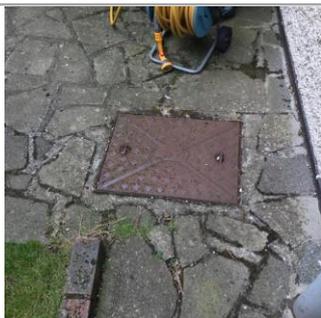
Inspection chambers are located to the side of the property. No blockages were visible at time of inspection.

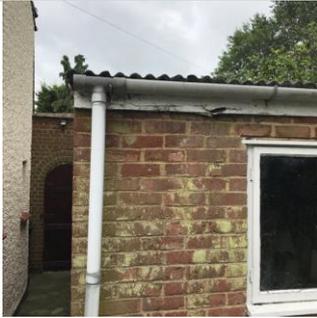
The fascia is rotting to the garage.

Cost of associated remedial work detailed in Section C, R12.

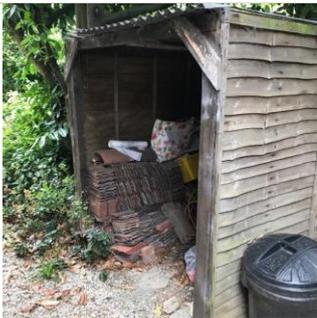
Timber store area to the right hand side is in a poor condition and we recommend this be removed.

Cost of associated remedial work detailed in Section C, R13.

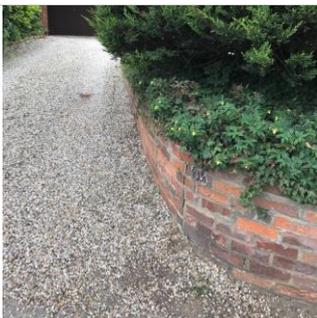
The retaining wall is loose and needs to be re-built.

Cost of associated remedial work detailed in Section C, R8.

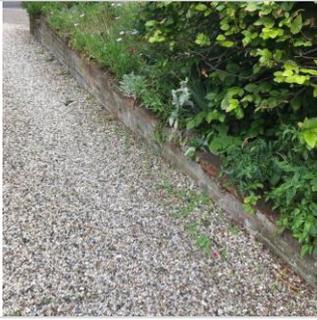
The retaining wall is loose and needs to be re-built.

Cost of associated remedial work detailed in Section C, R9.
