RICS Home Surveys

Survey level two: HomeBuyer report - Survey

26 February 2018

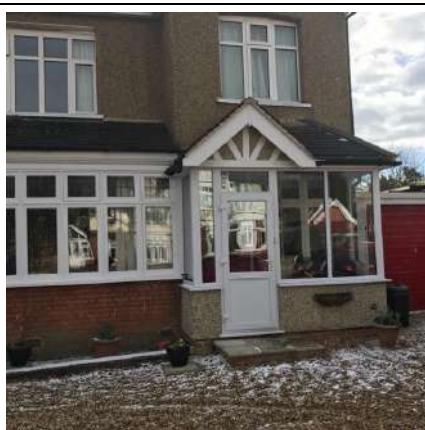
The roof tiled cement fillets designed to provide a weather tight seal between the wall and the roof covering. The fillet currently appears to be secure, however they are prone to fail and break up, which could allow water to run down into the roof space below. For this reason we would recommend the fillet be replaced with lead flashing.

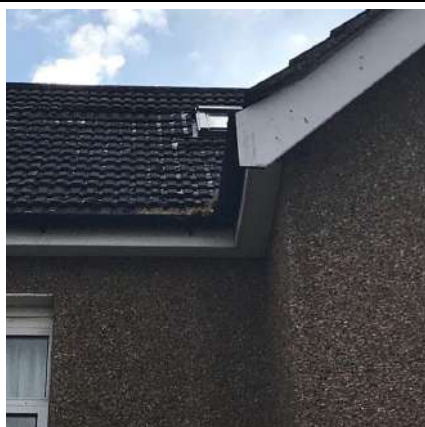
There is vegetation growing from the gutters to the front.

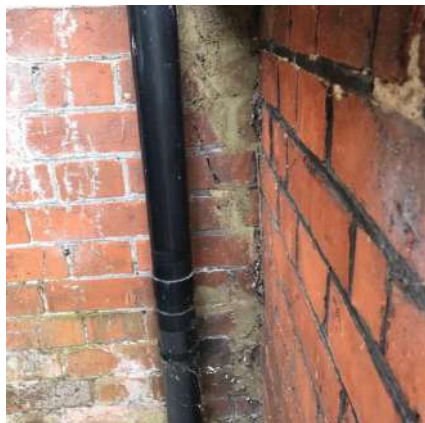
There is evidence of movement in the form of vertical cracks to the front elevation and we recommend this be monitored by a structural engineer with tell tale gauges to ensure this is not progressive. We suspect this to be original settlement, but cant be conclusive on one inspection.

Where there is evidence of previous movement to the property, it would be prudent to maintain the existing insurance cover to ensure there is continuity in the event of any future claim.

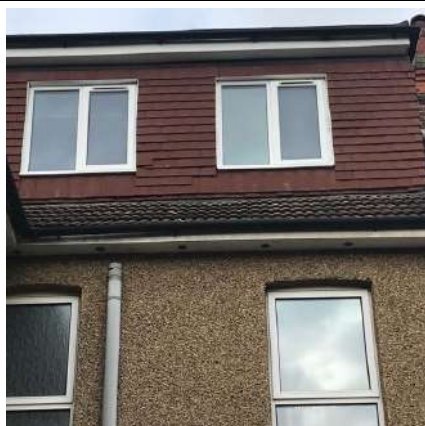
Missing wall hung tiles.

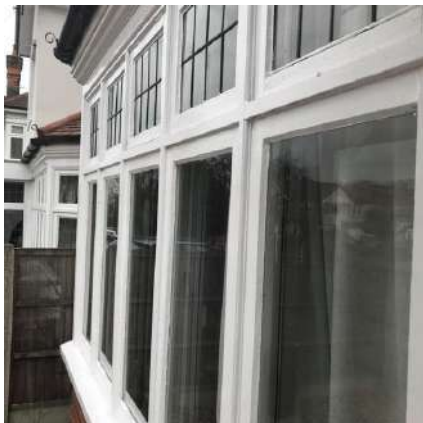
Although functional, the timber windows are generally at the end of their life cycle and would benefit from full replacement.

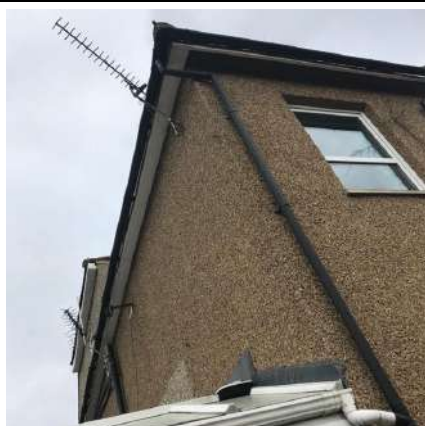
The fascia and soffit boards have not been well maintained. They require regular decoration approximately every five years to provide on-going weather protection. Annual maintenance is likely to have an impact on your budget and we therefore recommend you budget a sum with this in mind.

Fascia and soffit are not finished properly.

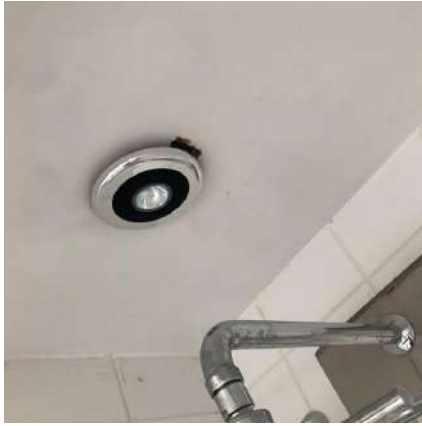
Allow to make good around fan

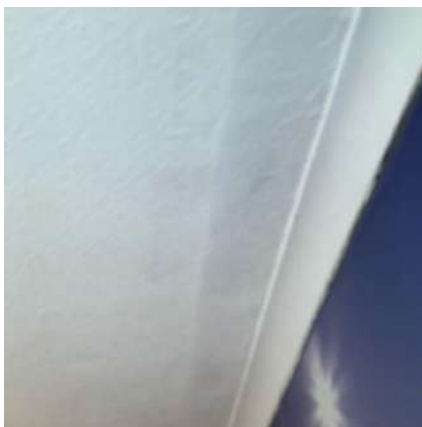
Bedroom 4

The ceiling is not secure to the ceiling joists and we recommend it be replaced.

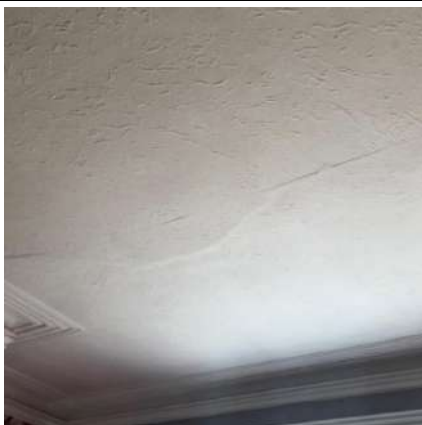
Living Room 1

The ceiling is not secure to the ceiling joists and we recommend it be replaced.

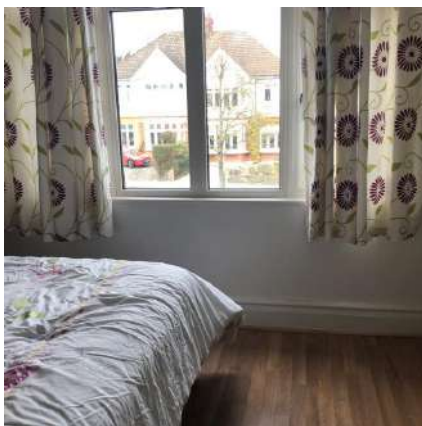
Bedroom 2

There is blown plaster that would benefit from being re-plastered.

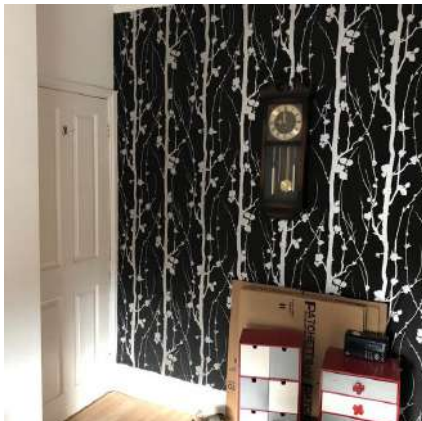
Bedroom 3

There is blown plaster that would benefit from being re-plastered.

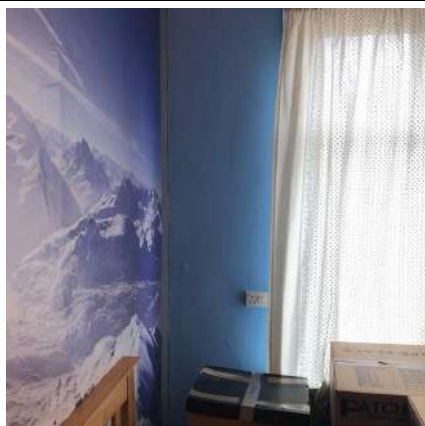
Bedroom 4

There is a poorly plastered area that would benefit from being re-plastered.

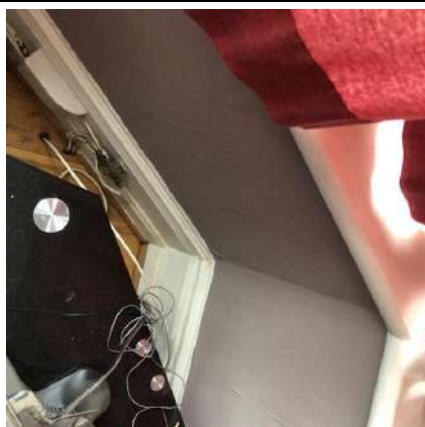
Living Room 1

There is blown plaster that would benefit from being re-plastered.

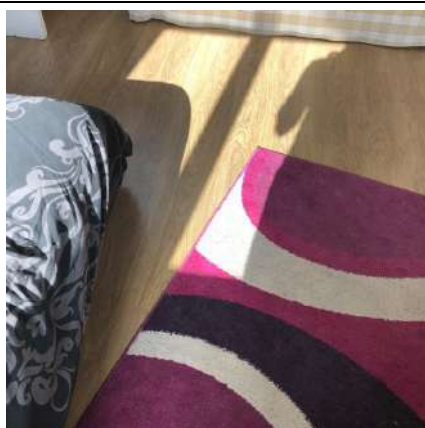
Master Bedroom

The floor would benefit from having the floorboards secured once floor coverings have been removed as there are loose floorboards resulting in creaking floors. This may simply be the result of poor workmanship.

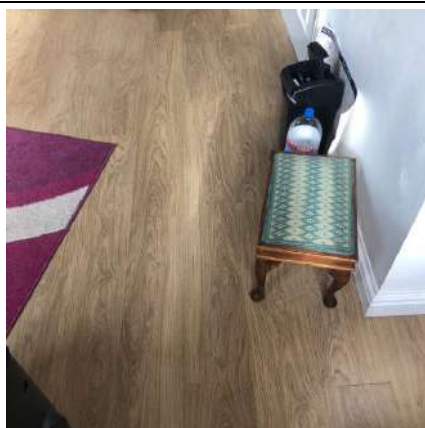
Master Bedroom / En Suite

Detailed investigation was prohibited by the presence of floor coverings that we were not at liberty to disturb, however where a heel test was applied, excessive bounce was found in the floor. This may simply be the result of poor workmanship.

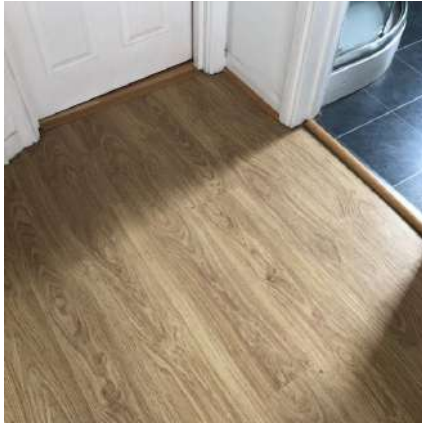
First Floor Landing

Further investigation is recommended due to the floor not being flat. This may simply be the result of poor workmanship.

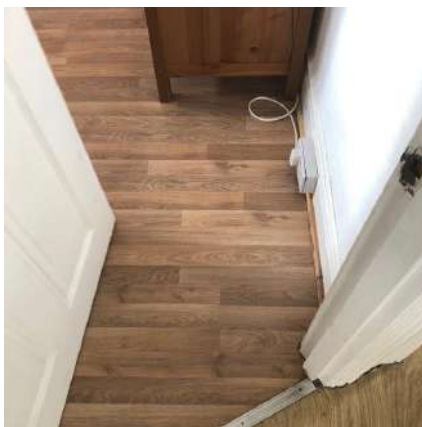
Bedroom 2

Further investigation is recommended due to the floor not being flat. This may simply be the result of poor workmanship.

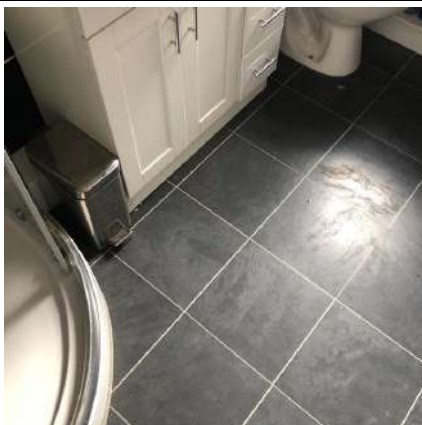
Bathroom

Further investigation is recommended due to the floor not being flat. This may simply be the result of poor workmanship.

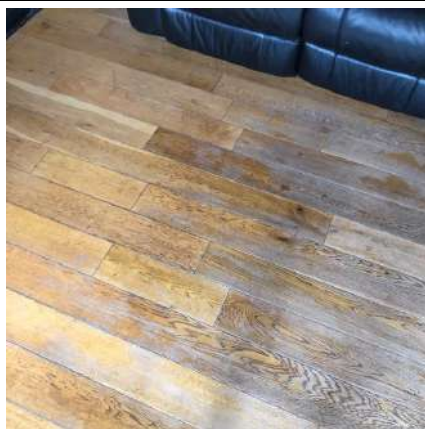
Living Room 1

Further investigation is recommended due to the floor not being flat. This may simply be the result of poor workmanship.

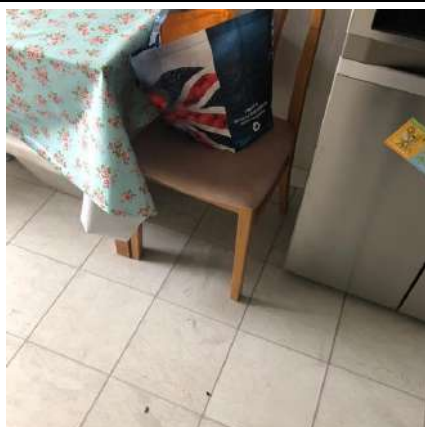
Conservatory 2

Further investigation is recommended due to the floor not being flat. This may simply be the result of poor workmanship.

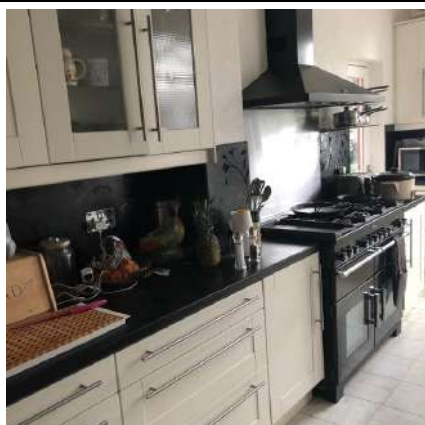
Kitchen

The kitchen units and components in general are showing wear and tear, but are functional.

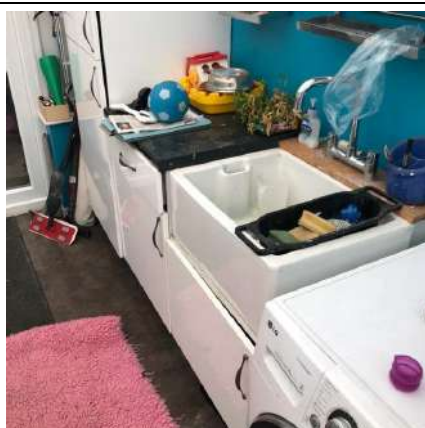
Conservatory 2

The utility area is in a tired condition and full refurbishment is recommended.

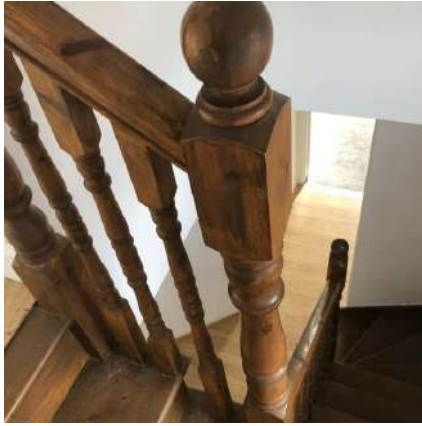
Allow to secure loose balustrade.

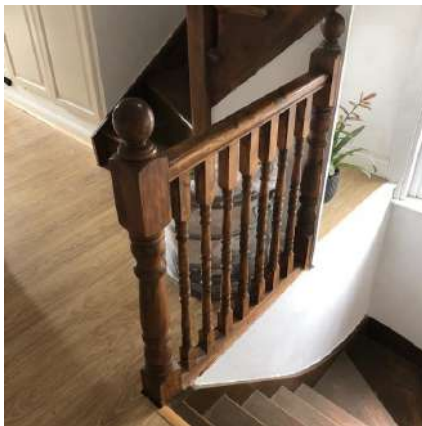
First Floor Landing

Allow to secure loose balustrade.

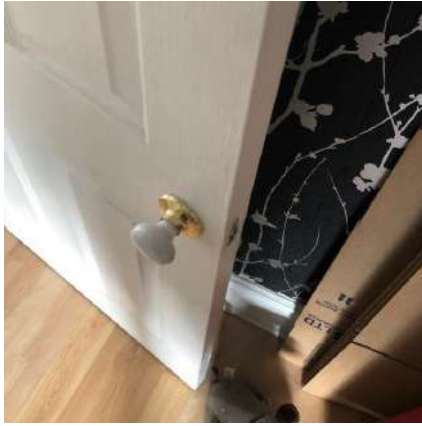
The door does not close correctly and needs to be eased and adjusted.

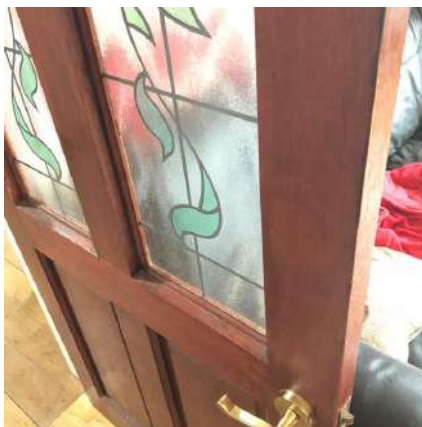
Living Room 1

Glazed doors are considered unsafe, especially with young children.

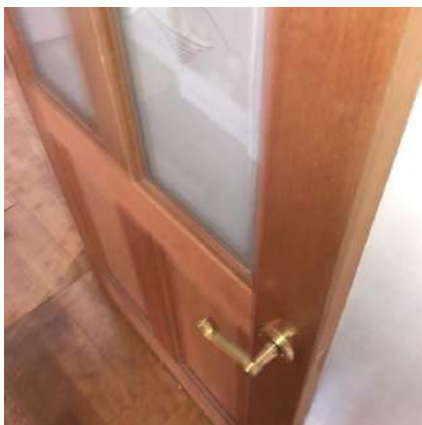
Living Room 2

Glazed doors are considered unsafe, especially with young children.

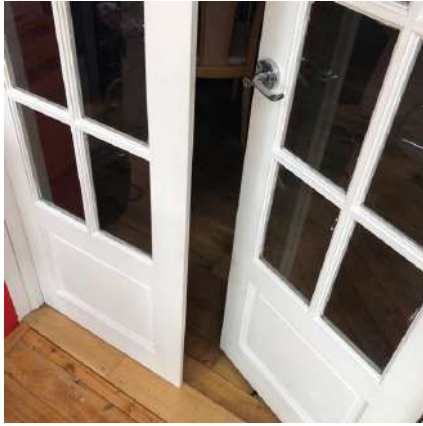
Conservatory 1

Glazed doors are considered unsafe, especially with young children.

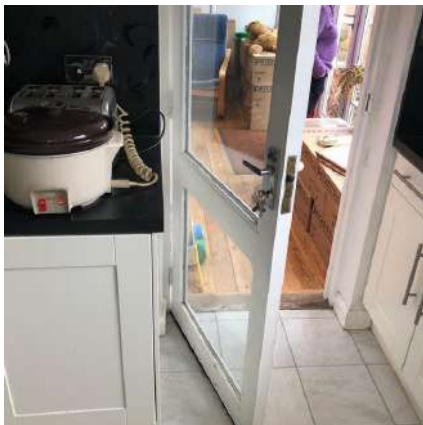
Kitchen

Glazed doors are considered unsafe, especially with young children.

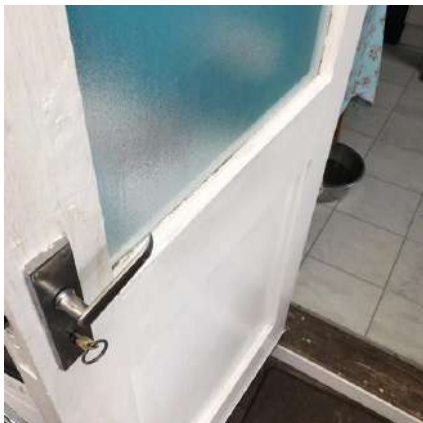
Conservatory 2

Glazed doors are considered unsafe, especially with young children.

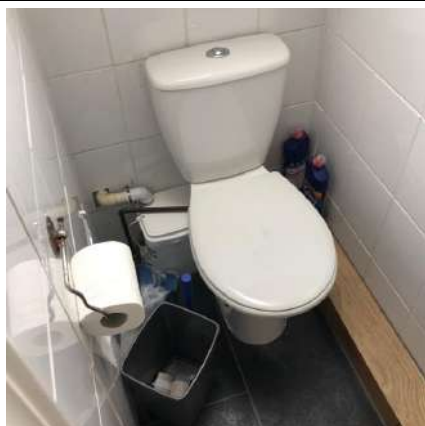
The En Suite fittings and components in general are showing wear and tear, but are functional.

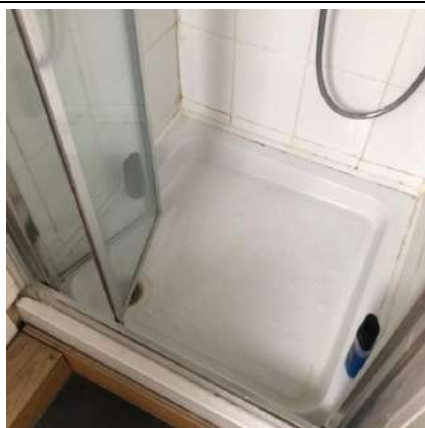
The mastic pointing is generally in poor condition and we recommend this be re-pointed with new mastic.

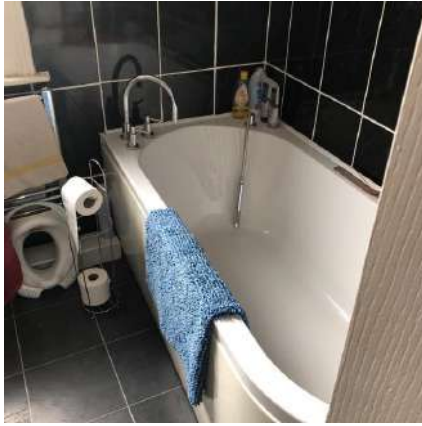
Bathroom

The bathroom fittings and components in general are showing wear and tear, but are functional.

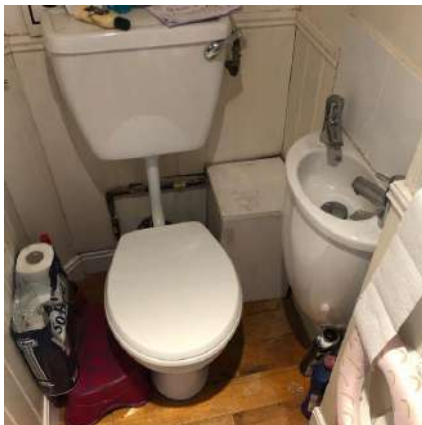
Separate Toilet

The WC fittings and components in general are showing wear and tear, but are functional.

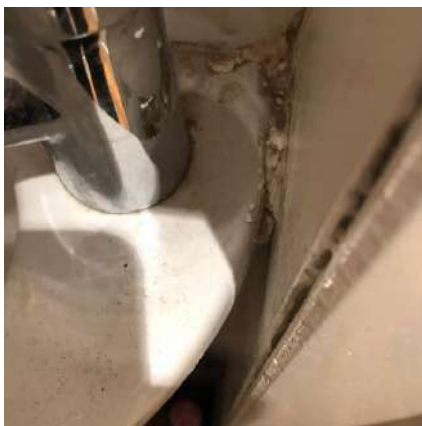
The mastic pointing is generally in poor condition and we recommend this be re-pointed with new mastic.

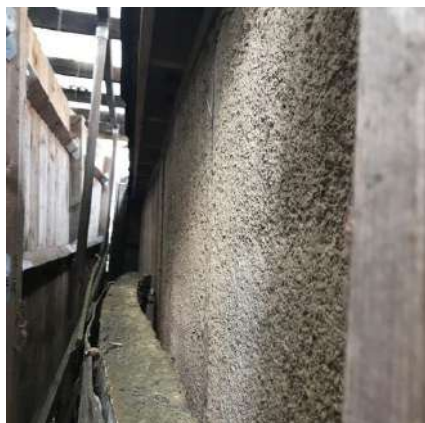
H1 Garage

The concrete frame to the garage has been significantly altered and is on the verge of collapse. The felt roof is also in poor condition.

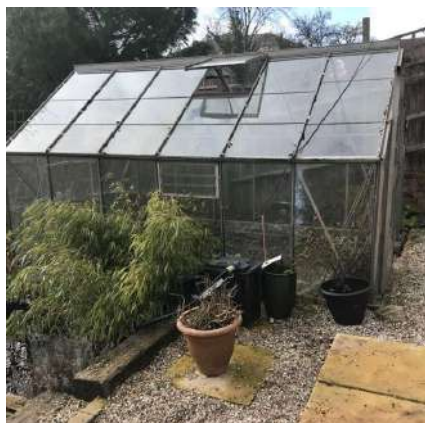
This structure is dangerous especially with young children.

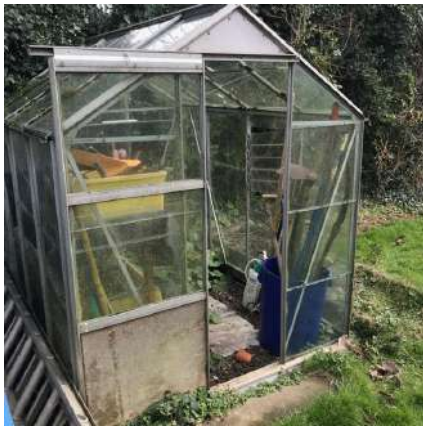
This structure is dangerous especially with young children.

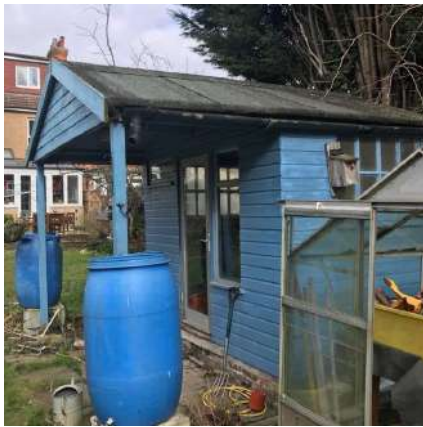
The shed is in poor condition.

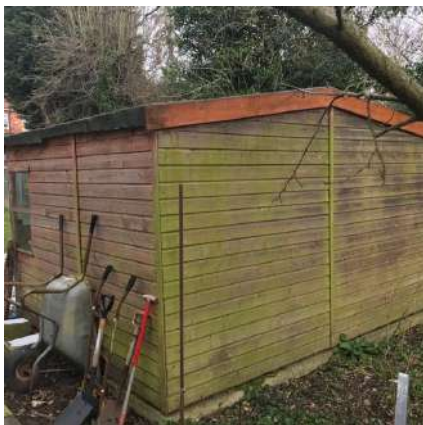
Timber shed is in reasonable condition, however the roof will need to be replaced

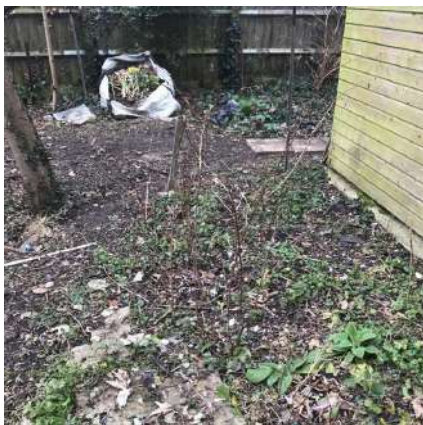
Suspect Japanese knotweed identified to the rear and we recommend a specialist be commissioned to confirm. Japanese knotweed is an invasive and resilient weed. Its roots and rhizomes can grow to a depth of 2 metres. Even after herbicide treatment has eradicated the aerial and surface growth, the deep underground rhizomes can remain in a viable state, and may do so for up to twenty years. It can re-emerge and re-grow of its own accord at any time, and especially if the contaminated ground is disturbed.

If knotweed is left to grow untreated for a number of years, it has the potential to cause damage to drains, paving, paths, driveways and walls. For this reason, it should not be ignored.

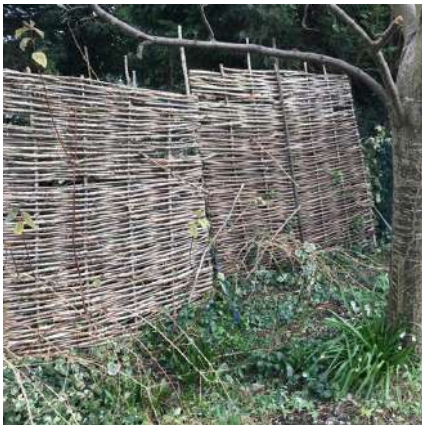
The timber fencing is in poor condition and needs to be replaced.
