RICS Home Surveys

Survey level two: HomeBuyer report - Survey

Able Surveyors Limited

24 September 2018

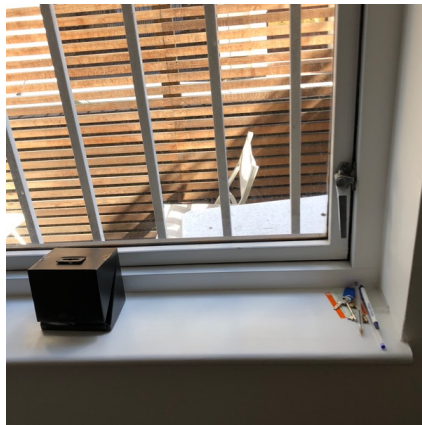
The timber windows and frames have been reasonably well maintained. These will require regular maintenance and decoration approximately every five years to provide on-going weather protection.

All windows would benefit from being serviced due to age, wear and tear.

We highly recommend that all windows are serviced annually to ensure they are safe and functional. Annual maintenance is likely to have an impact on your budget and we therefore recommend you budget a sum with this in mind.

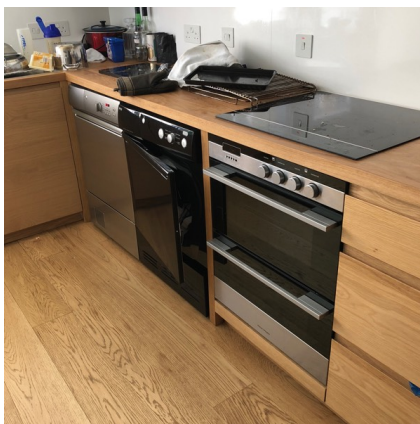
Kitchen

The kitchen units and components in general are showing wear and tear, but are functional.

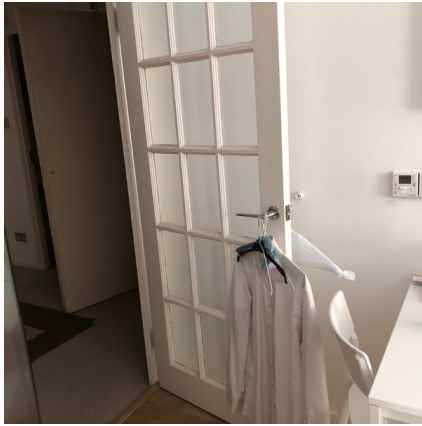
Glazed doors are considered unsafe, especially with young children.

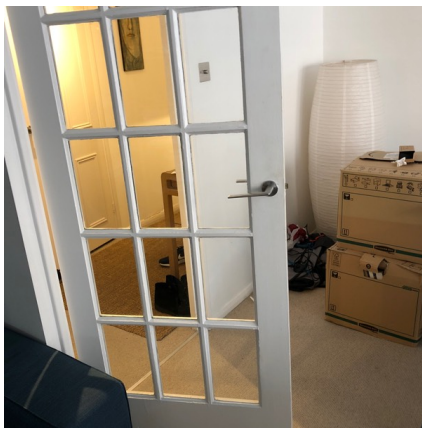
Living Room

Glazed doors are considered unsafe, especially with young children.

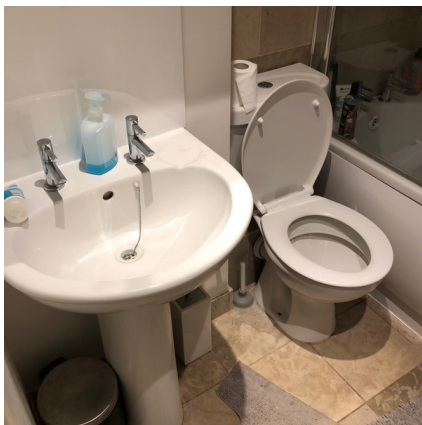
The bathroom has the following components: bath, wash hand basin, close-coupled WC, shower valve shower head attachment and shower screen.

The bathroom fittings and components in general are showing wear and tear, but are functional.

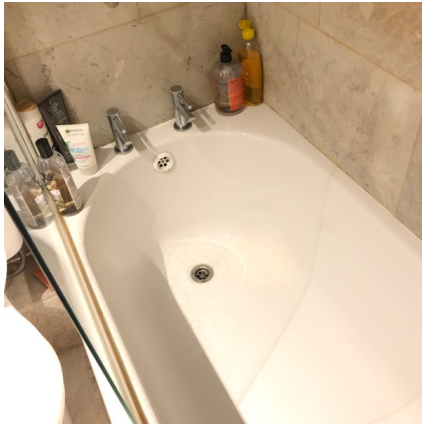
The mastic pointing is generally in poor condition and we recommend this be re-pointed with new mastic.

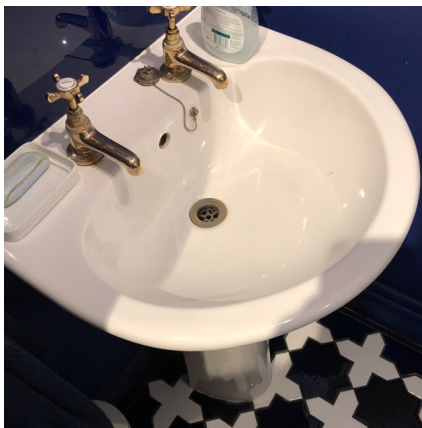
Separate Toilet

The WC has the following components: wash hand basin and close-coupled WC.

The WC fittings and components in general are showing wear and tear, but are functional.

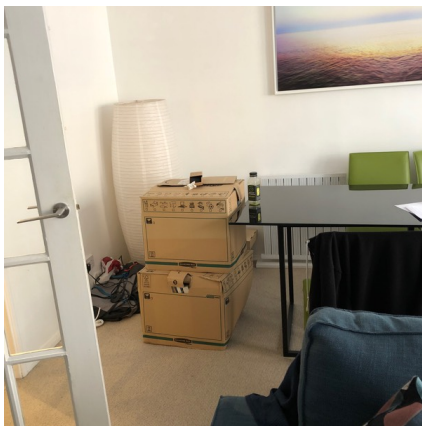
This property would benefit from internal decorations.

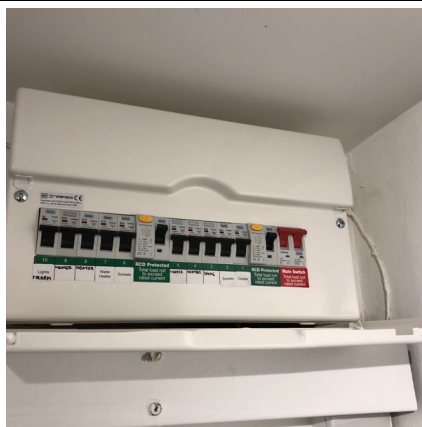
There is a mains supply and the electricity was on when we inspected. The consumer board is located in the hall and the electricity meter is cupboard under the stairs. The consumer unit is a relatively modern unit with miniature circuit breakers and RCD.

Please note: Although the electrics work and look safe, it does not mean that they are safe. The only way to be absolutely certain is for a qualified electrician to test the circuits and provide a Periodic Inspection Report.

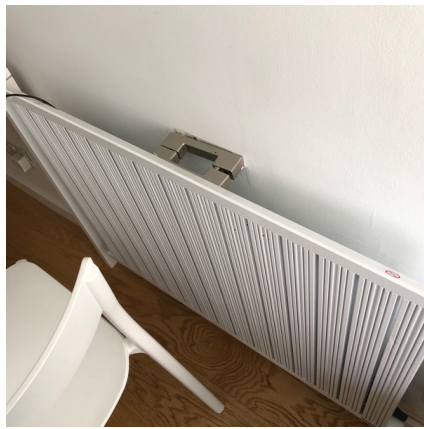
Loose radiator to kitchen that needs securing.
