# Your survey report...

Property address

Inspection date

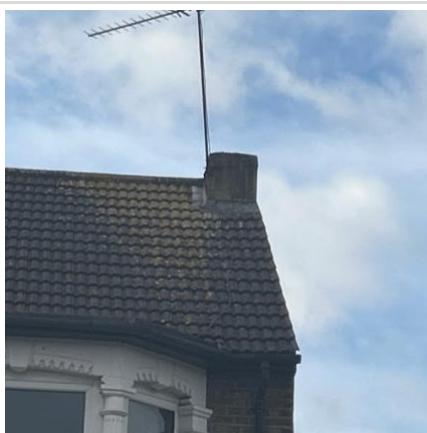
(Condition Rating 2)

The render is in poor condition and we recommend the chimney stack be re-rendered.

This work would be the responsibility of the Freeholder / Managing agent. Depending on the terms of your lease you may be liable to pay a proportion of the repair costs.

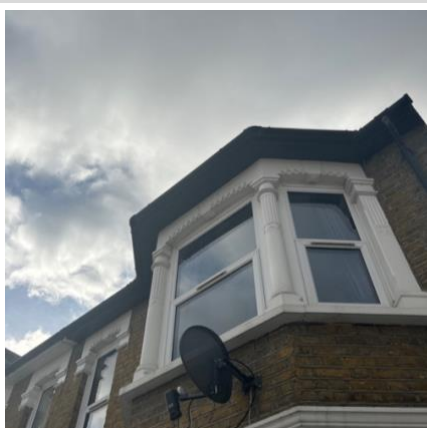
(Condition Rating 2)

There is evidence of leaking gutters to the front and rear.

uPVC guttering will expand and contract during changes of temperature and this will place stress on the gutter joints. Repairs are likely to be required from time to time to ensure that the guttering remains completely watertight.

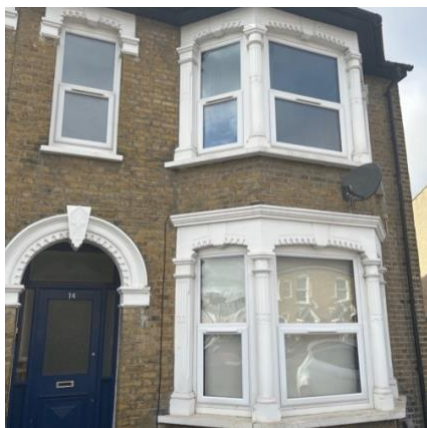
(Condition Rating 2)

The cement mortar has worn away from the face brickwork and this needs to be replaced to ensure the brickwork remains weather tight. This is known as pointing.

This work would be the responsibility of the Freeholder / Managing agent. Depending on the terms of your lease you may be liable to pay a proportion of the repair costs.

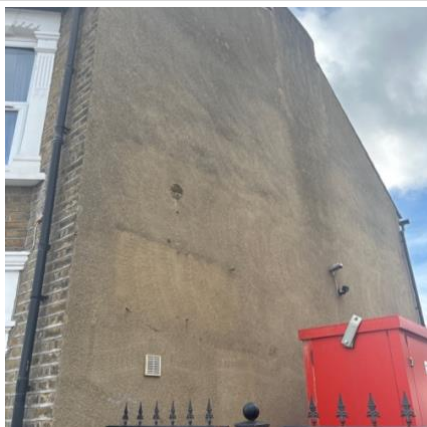
(Condition Rating 2)

The render is in poor condition on the right hand side elevation.

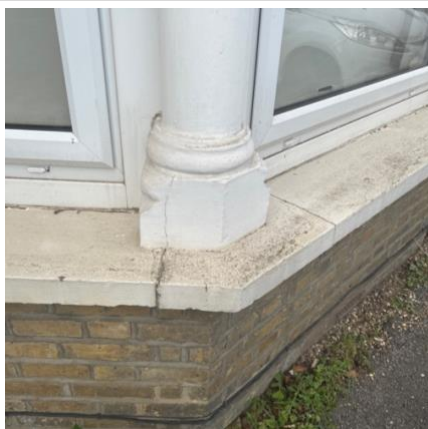
(Condition Rating 2)

The stonework to the window is in poor condition and we recommend this be repaired.

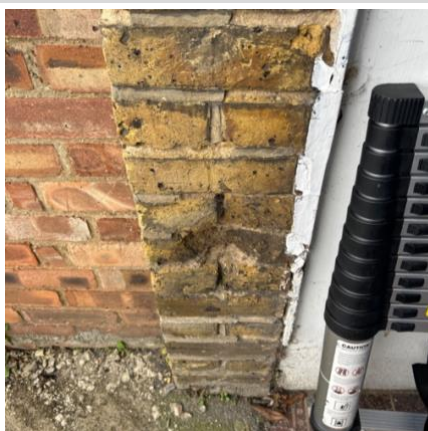
(Condition Rating 2)

There are areas of the wall that would benefit from being made good.

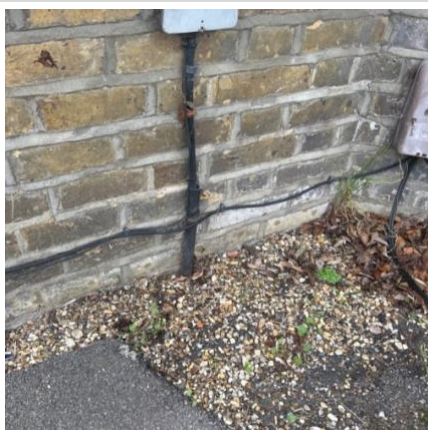
There is evidence of damp proofing work to the external walls in the form of chemical injection drill holes.

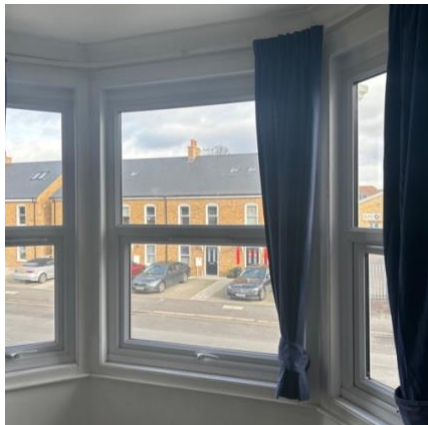
(Condition Rating 2)

All windows would benefit from being serviced due to age, wear and tear. Allow to service the windows including removing, lubricating, replacing defective seals, gaskets, mastic, trickle vents and handles; and refitting furniture.

We highly recommend that all windows are serviced annually to ensure they are safe and functional. Annual maintenance is likely to have an impact on your budget and we therefore recommend you budget a sum with this in mind.

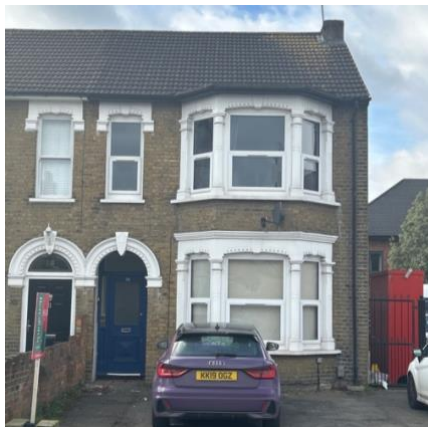
### D9 Other

(Condition Rating 2)

External decorations are starting to deteriorate and would benefit from re-decoration. It is inevitable that some repairs and making good will be required when preparing to decorate, including isolated timber and masonry repairs.

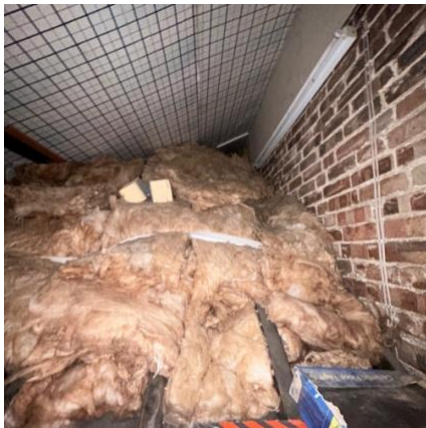
(Condition Rating 2)

The insulation has been disturbed and would benefit from being re-laid flat.

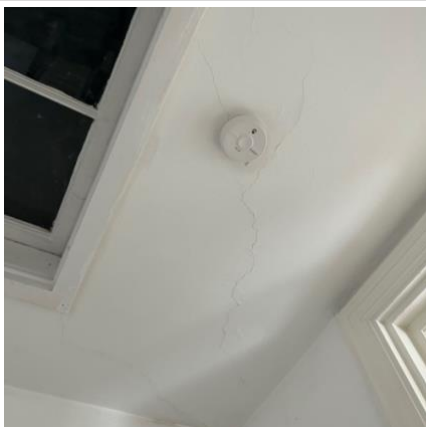
(Condition Rating 3)

The ceilings are poorly finished and would benefit from being taken down, plaster boarded and skimmed.

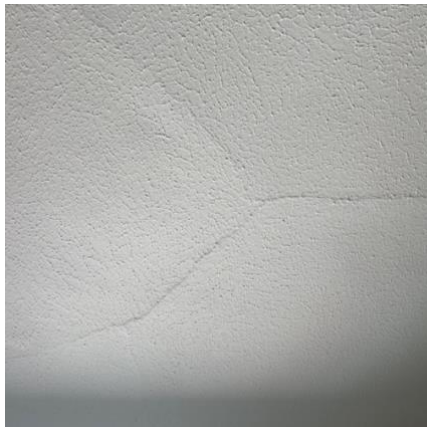
### Kitchen

(Condition Rating 3)

Flaking textured coating: We recommend this is sampled by an asbestos surveyor / company and sent for analysis.

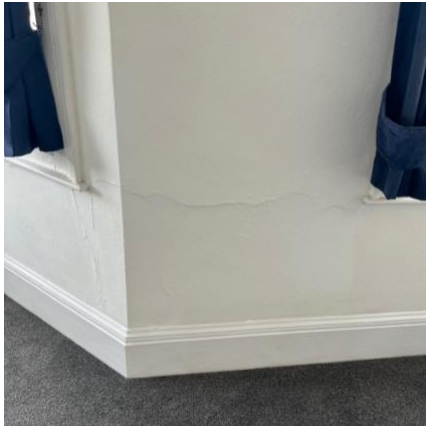
(Condition Rating 3)

There is defective plaster throughout the property that would benefit from being re-plastered.

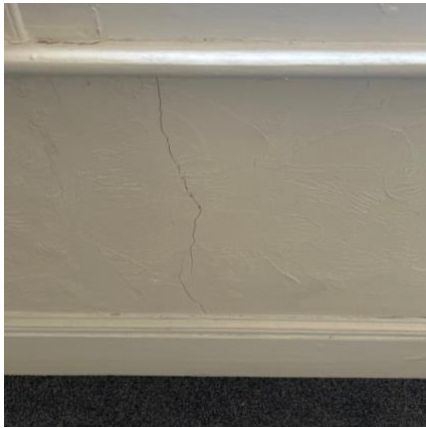
### Bedroom

(Condition Rating 3)

Flaking textured coating: We recommend this is sampled by an asbestos surveyor / company and sent for analysis.

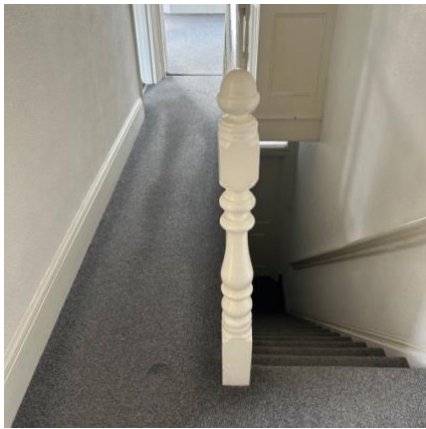
(Condition Rating 2)

The floors in general would benefit from having the floorboards secured once floor coverings have been removed as there are loose floorboards resulting in creaking floors. This may simply be the result of poor workmanship and further investigation is recommended.

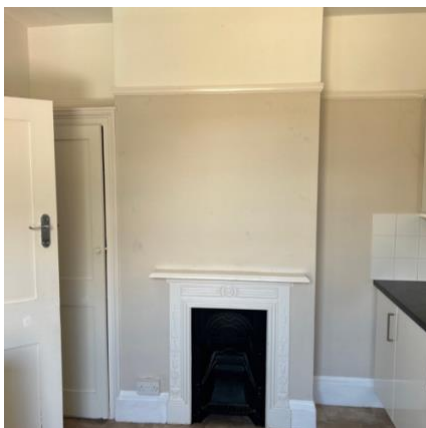
#### Kitchen

The chimney breast has an opening for a solid fuel fire.

There was no up to date Smoke Test certificate visible at the time of inspection and therefore a Condition Rating 3 has been applied.

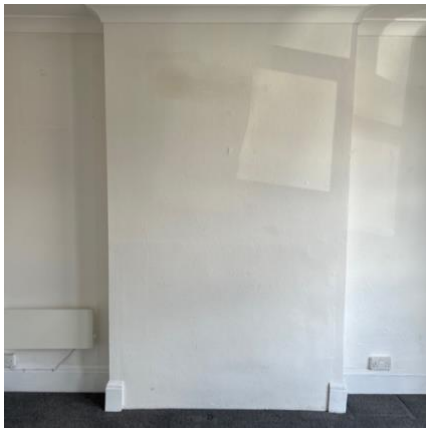
### Living Room

(Condition Rating 2)

No ventilation to chimney breast. We recommend this be vented with a plaster vent.

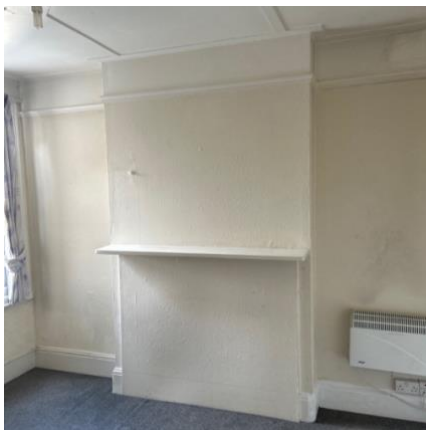
### Bedroom

(Condition Rating 2)

No ventilation to chimney breast. We recommend this be vented with a plaster vent.

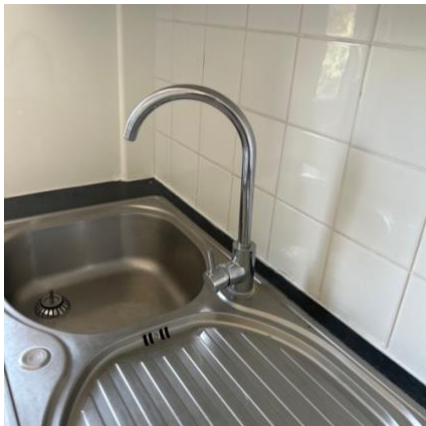
(Condition Rating 2)

The mastic between the wall and work surface is in poor condition and we recommend new pointed mastic.

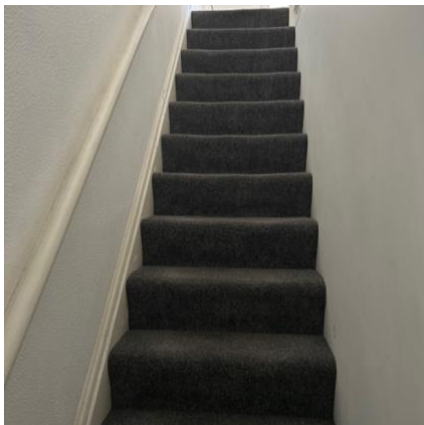
(Condition Rating 2)

The staircase has loose treads.

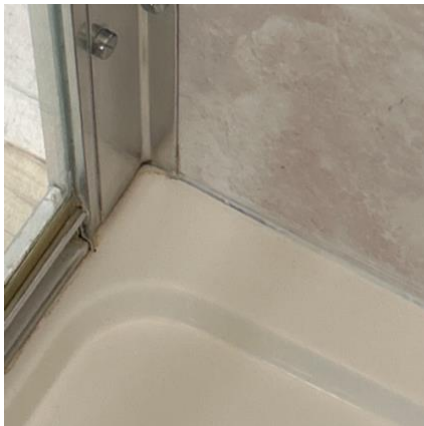
(Condition Rating 2)

The mastic pointing is generally in poor condition and we recommend this be re-pointed with new mastic.

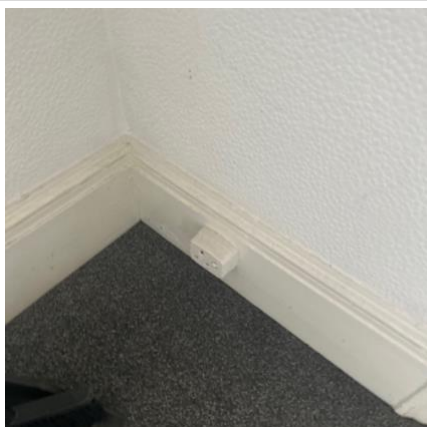
(Condition Rating 3)

Old electrical fittings.

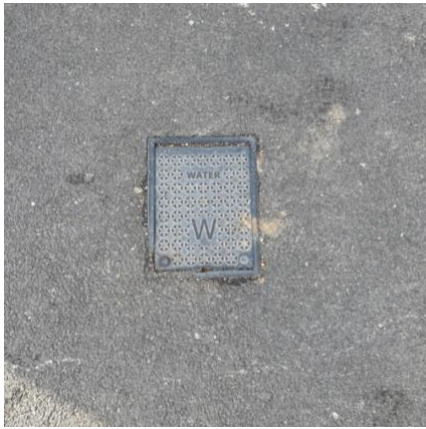
### F3 Water

There is a mains water supply to the property. The main stopcock is located on the front path.

There is no visibility of the water main coming in to the property. Further investigation is recommended, as this may be run in lead pipe. If found to be lead, we recommend its replacement.

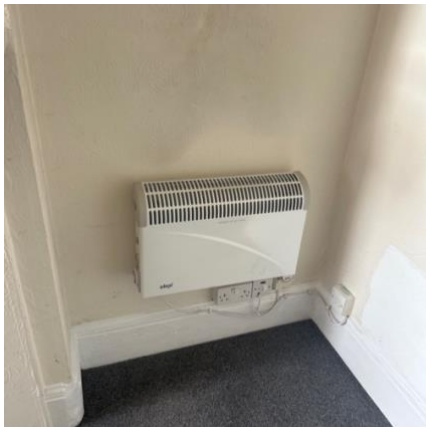
### F4 Heating

This property benefits from panel heaters and these have temperature control.

There was no up to date Electrical Installation Condition Report for the electric heating at the time of inspection and therefore a Condition Rating 3 has been applied.

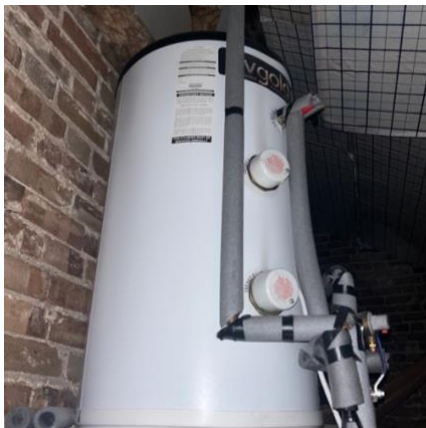
### F5 Water heating

Water heating is by electric immersion. Water is heated and stored in the hot water cylinder located in the hall cupboard. Water heats up overnight on cheaper rate electricity subject to agreement with the service provider.

There was no up to date Electrical Installation Condition Report for the electrics at the time of inspection and therefore a Condition Rating 3 has been applied.

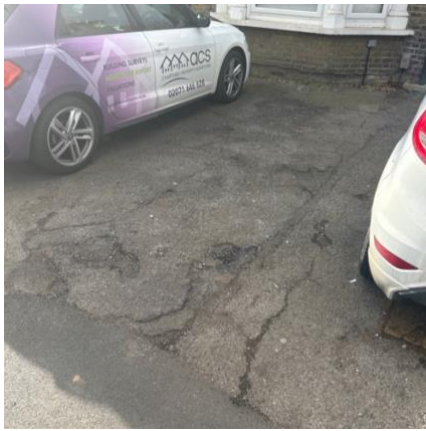
(Condition Rating 2)

The hard standing to the front is uneven and needs to be re-landscaped.

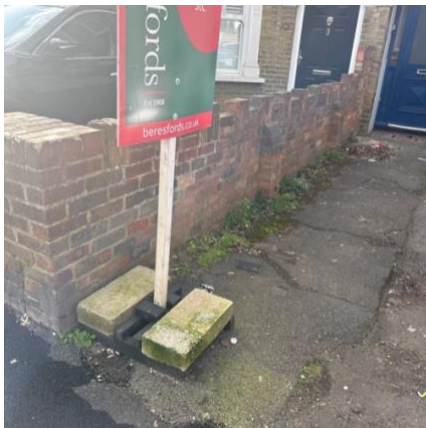
(Condition Rating 2)

The boundary wall is loose and needs to be re-built.
