LEVEL 3

Your survey report...

Contents

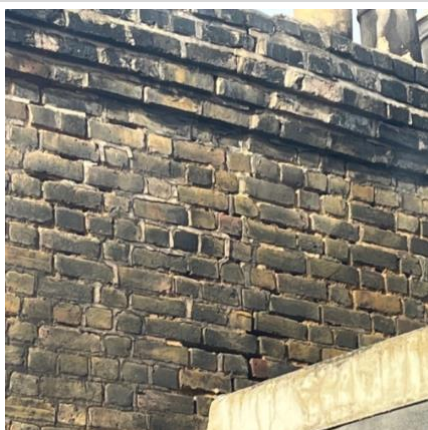
(Condition Rating 2)

The cement mortar has worn away from patches of the brickwork and this needs to be replaced to ensure the chimney stacks remains secure and watertight. This is known as pointing.

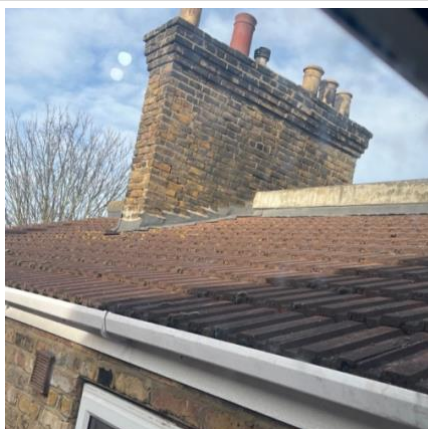
(Condition Rating 3)

The flashing to the roof is defective, as there is evidence of penetrating damp to the ceilings below. The roof needs to be overhauled.

Cost of associated remedial work detailed in Section B, R49

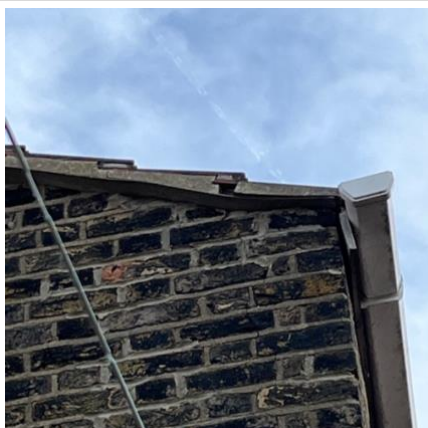
(Condition Rating 2)

There is defective pointing to the verge.

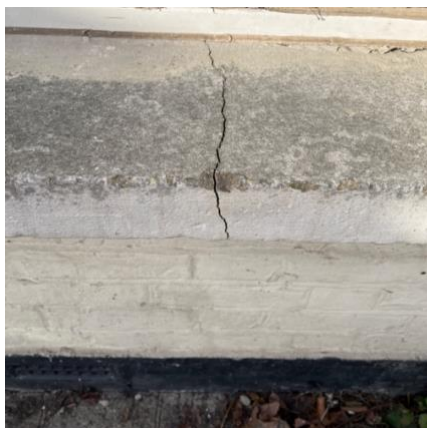
(Condition Rating 3)

The stonework to the window is in poor condition and we recommend this be repaired.

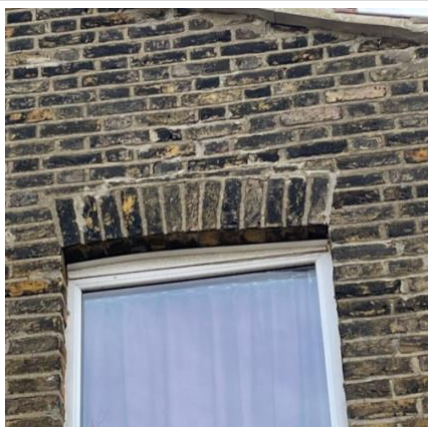
(Condition Rating 3)

Signs of distortion and distress, with localised cracking, were noted to the external brick arch.

Cost of associated remedial work detailed in Section B, R39

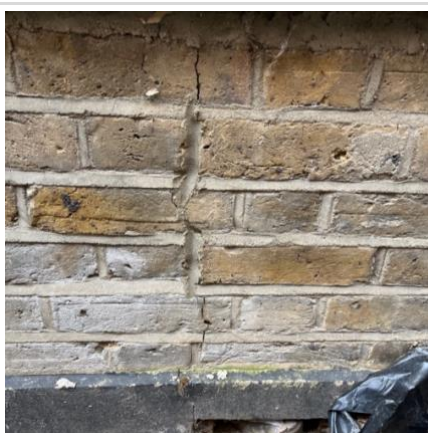
(Condition Rating 3)

There is evidence of movement in the form of vertical cracks to the rear elevation and we recommend this be monitored with a digital calliper to ensure this is not progressive.

As per BRE digest 251, the crack has a category of damage rating 1.

Cost of associated remedial work detailed in Section B, R46

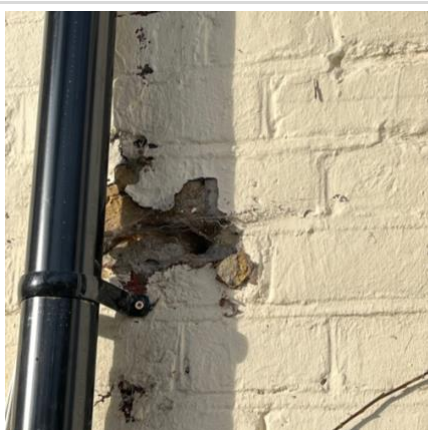
(Condition Rating 2)

There are areas of the wall that would benefit from being made good.

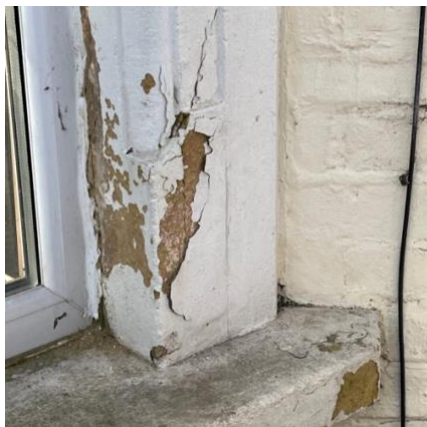
(Condition Rating 2)

The render has blown on the front elevation. When it is blown it means that the render is not sticking to the wall in places. Blown render can be caused by dampness getting underneath or by deteriorating older render that is literally falling off the walls.

Cost of associated remedial work detailed in Section B, R52

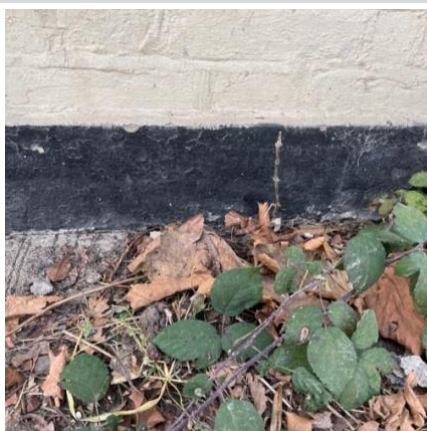
(Condition Rating 2)

The external render appears to have bridged the damp proof course. The damp proof course is not visible and further investigation is required to ascertain whether there actually is one. Lack of damp proof course or a bridged damp proof course can contribute to damp issues and needs to be rectified.

Cost of associated remedial work detailed in Section B, R54

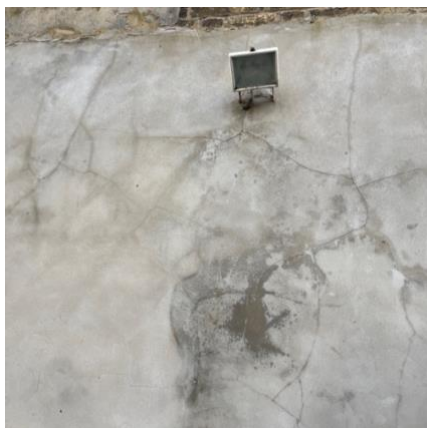
(Condition Rating 2)

The render has been poorly applied on the rear elevation.

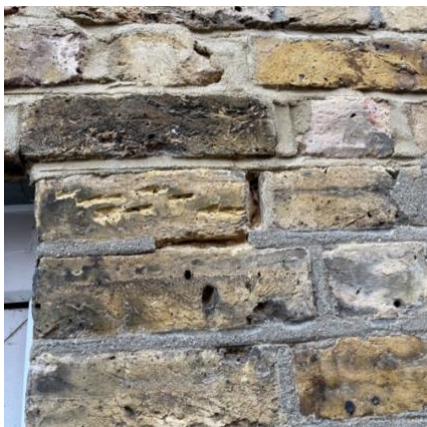
(Condition Rating 2)

The cement mortar has worn away from the face brickwork and this needs to be replaced to ensure the brickwork remains weather tight. This is known as pointing.

Cost of associated remedial work detailed in Section B, R57

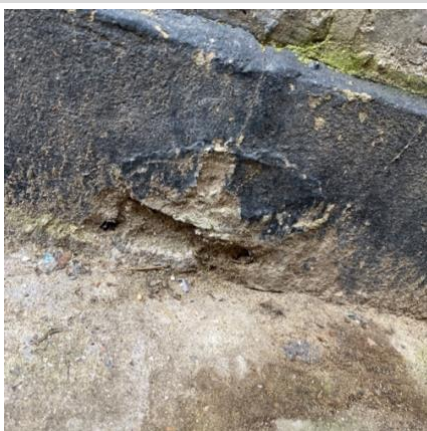
(Condition Rating 2)

There is a traditional sand and cement plinth to the base of the external walls. This has blown on the rear elevation.

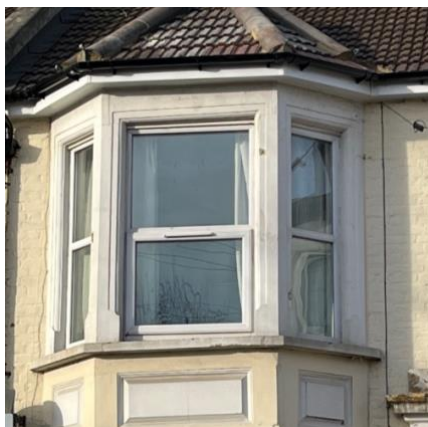
(Condition Rating 2)

All windows would benefit from being serviced due to age, wear and tear. Allow to service the windows including removing, lubricating, replacing defective seals, gaskets, mastic, trickle vents and handles; and refitting furniture.

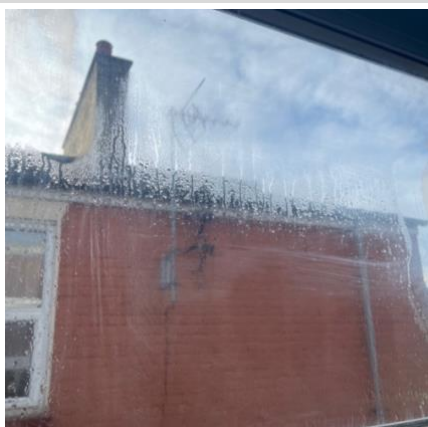
(Condition Rating 2)

Failed double-glazed units that needs replacing. A failed double-glazed unit is when the unit's seal has broken down allowing moisture in between the two panes of glass. This is very visible.

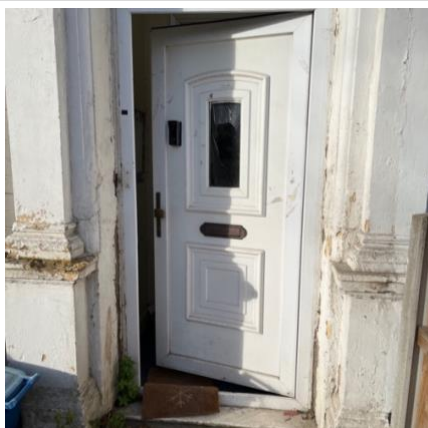
(Condition Rating 2)

Although functional, the door is generally at the end of its life cycle and would benefit from full replacement.

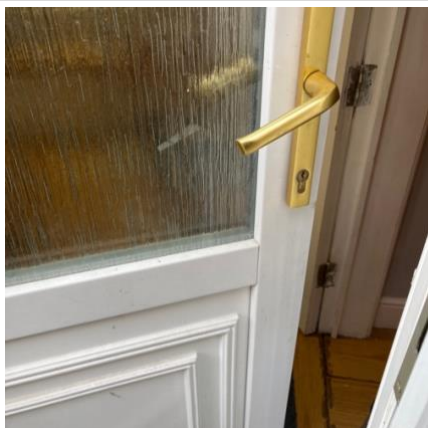
(Condition Rating 2)

The door would benefit from a general service and being eased and adjusted. Allow to ease and adjust door including removing, lubricating and refitting of doors, refitting door stop or gaskets; or replacing, furniture or replacing for new and making good holes where necessary to frames and doors.

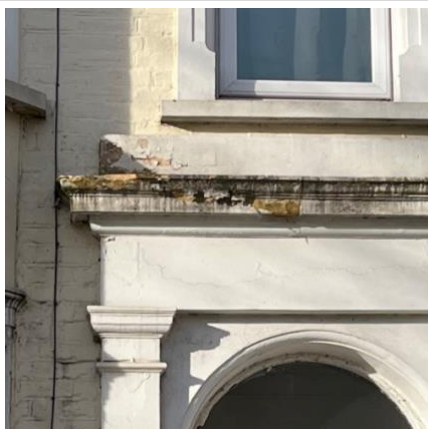
(Condition Rating 2)

The concrete to the canopy is in poor condition and we recommend this is made good.

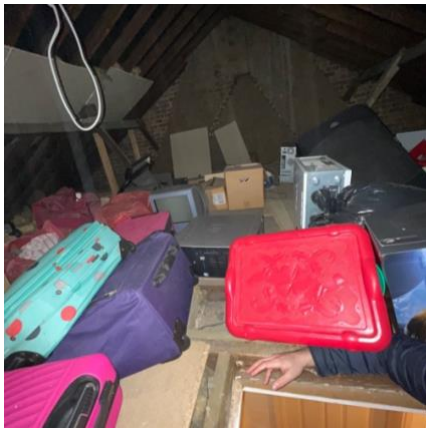
(Condition Rating 2)

The loft space is being used for storage and there is a risk of over loading causing distortion to the timbers and ceilings below.

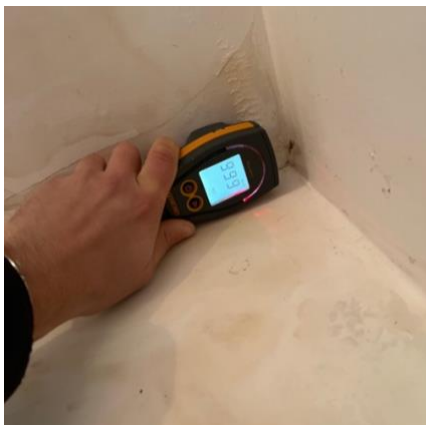
(Condition Rating 3)

There is penetrating damp to the ceiling that requires further investigation.

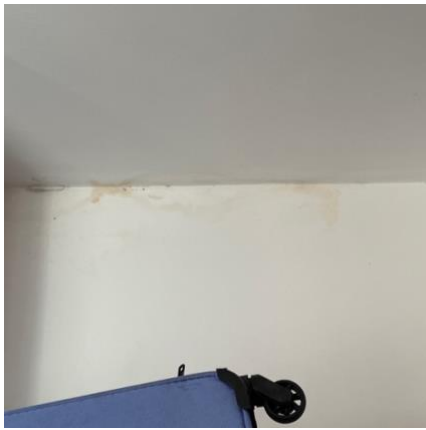
(Condition Rating 3)

There is evidence of staining to the ceiling and left-hand side party wall, however we were not able to take a damp reading due to furniture in the way. Given there is damp to this room we have assumed this area is also damp.

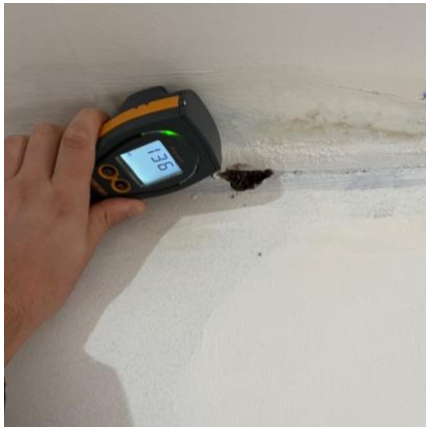
There is staining to the ceiling however this was found dry at time of inspection. This can be rectified within internal decorations.

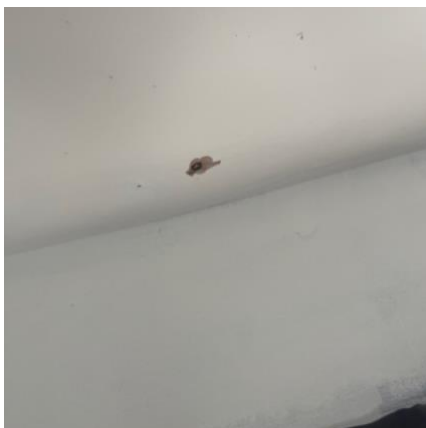
(Condition Rating 2)

The ceiling is poorly finished and would benefit from being skimmed.

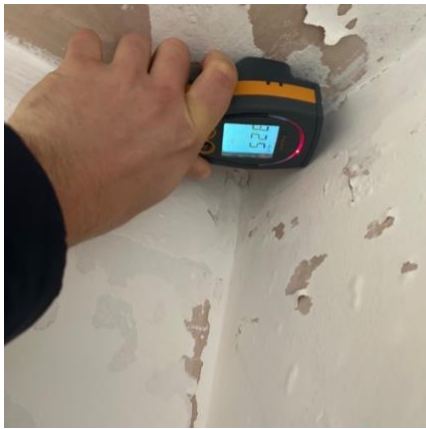
(Condition Rating 3)

There is penetrating damp to the ceiling that requires further investigation.

Cost of associated remedial work detailed in Section B, R20

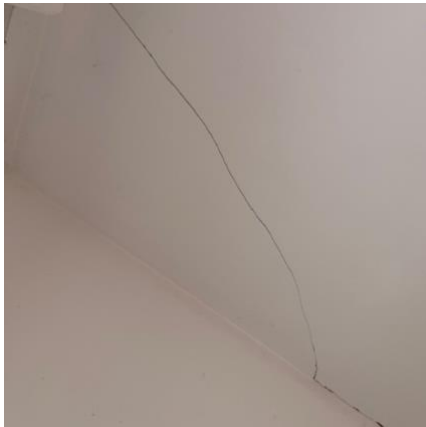
(Condition Rating 2)

The ceiling is poorly finished and would benefit from being taken down, plaster boarded and skimmed.

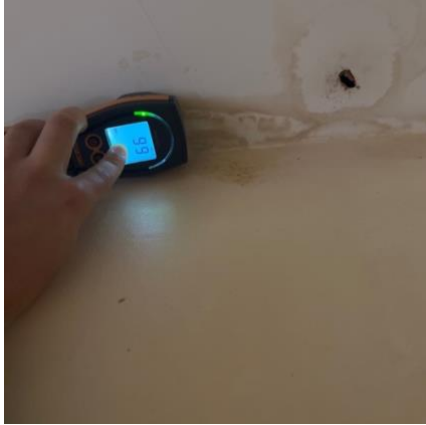
There is evidence of staining to the ceiling however this was found dry at time of inspection. It his can be rectified within internal decorations.

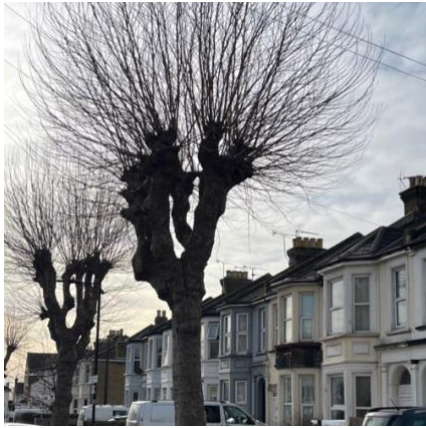
There are some trees within close proximity to the property that could possibly pose a risk. We recommend an arboriculturist report. All trees and shrubs should be regularly maintained and pruned regardless of risk.
