RICS  
**Building Survey** ●●●

Property address  
Clients name  
Date of inspection 27 July 2017  
Market valuation £747,000.00  
Insurance reinstatement costs £445,000.00

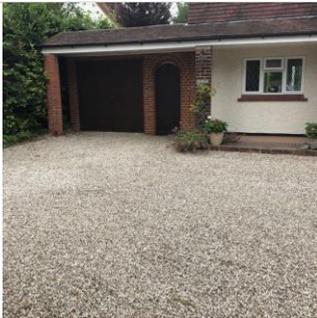
Landscape to front.

The retaining wall is loose and needs to be re-built.

Cost of associated remedial work detailed in Section C, R9.
