RICS Home Surveys

Survey level two: HomeBuyer report - Survey

26 February 2018

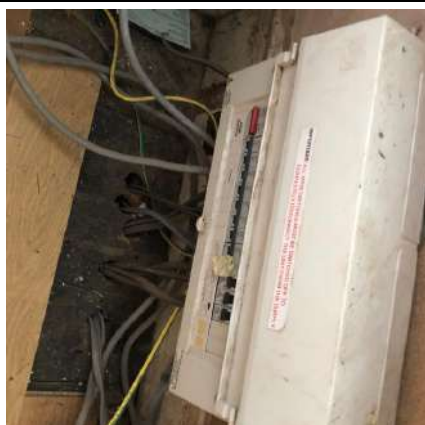
There is a mains supply and the electricity was on when we inspected. The consumer board and electricity meter are located in the hall. The consumer unit is a relatively modern unit with miniature circuit breakers and RCD.

Please note: Although the electrics work and look safe, it does not mean that they are safe. The only way to be absolutely certain is for a qualified electrician to test the circuits and provide a Periodic Inspection Report.

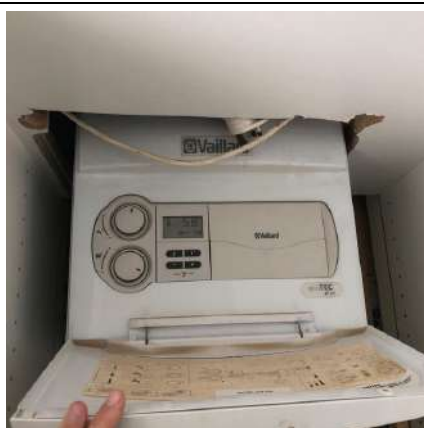
The Vaillant gas fired, conventional boiler in the kitchen provides central heating via single and double panel radiators located throughout the accommodation. The central heating system was not in operation at the time of inspection and although the gas boiler is a relatively modern appliance we cannot confirm that it is in safe working order.

We recommend that you establish the service history of the system prior to your commitment to purchase the property as only regular servicing by a competent person can ensure its future efficiency and safety. If your enquiries indicate that previous maintenance has been inadequate then the whole system should be checked by a competent engineer prior to purchase.
