# Your survey report...

Property address

Inspection date

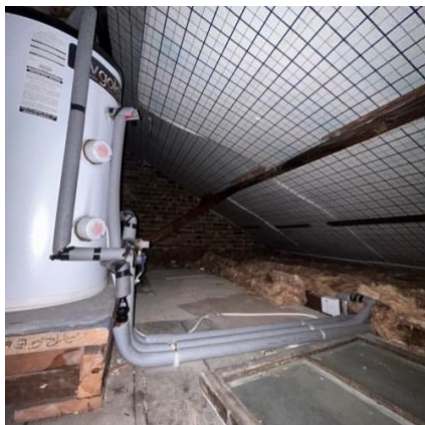
## E1 Roof structure

The rear roof space is accessed via a loft hatch on the landing. There is no fixed loft ladder. The roof is a cut and pitched timber construction. The roof appeared to be generally secure with no signs of thrust, deflection or water ingress.

The loft has been boarded. Mineral fibre quilt loft insulation has been laid between the ceiling joists to a depth of about 100mm. This is not a defect, but as most of the heat in a property escapes through the roof, you may wish to increase the depth of the loft insulation to at least 270mm, in line with current standards to minimise heat loss from below. The boarding will have to be removed to achieve this however or the roof can be insulated at rafter level.

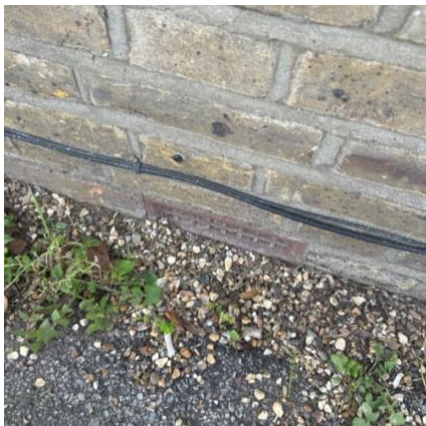
The floor structure is timber with floor boarding supported by suspended timber joists.

There is ventilation to the sub-floor void visible in the form of airbricks. Care should be taken to ensure airbricks are not blocked as lack of ventilation can cause problems such as dry rot.

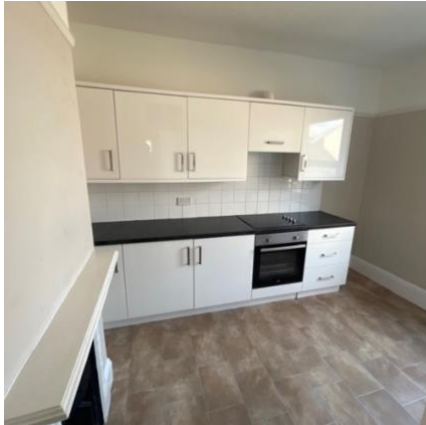
#### Kitchen

The kitchen has a range of wall and base units with laminate worktops, a stainless steel sink and a mixer tap. There are the following integrated appliances: single oven, hob and extraction hood.

The kitchen units and components in general are showing wear and tear, but are functional.

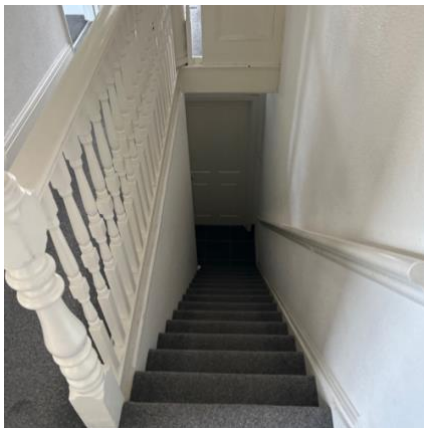
#### Main Hall

The staircase runs from the entrance hall to the main hall and consists of timber treads and risers covered with a closely fitted carpet.

You should be aware that older staircases in particular can be prone to problems such as loosening of stair treads and occasional maintenance may be required.

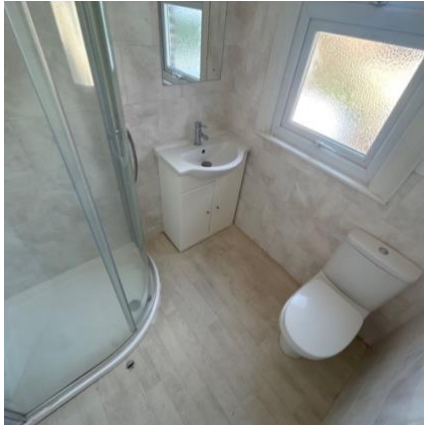
#### Shower Room

The shower room has the following components: wash hand basin, close-coupled WC, shower valve with shower head attachment and shower cubicle.

The shower room fittings and components in general are showing wear and tear, but are functional.

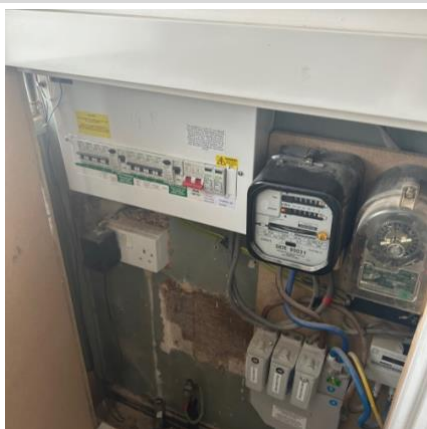
## F1 Electricity

There is a mains supply and the electricity was on when we inspected. The consumer board and electric meter are located in the communal hall. The consumer unit is a relatively modern unit with miniature circuit breakers and RCDs.

This property has a variety of light fittings and there appeared to be adequate socket outlets.

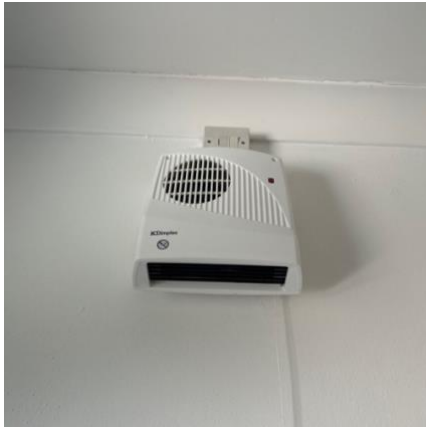
### Shower Room

This area has an electric fan heater.

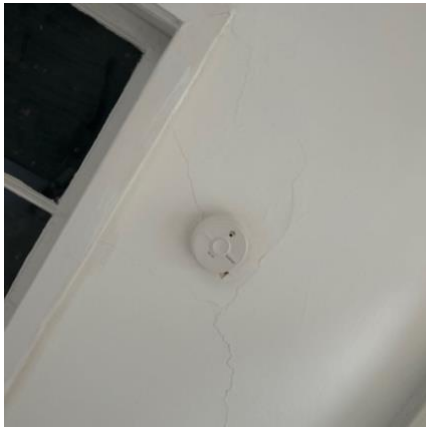
### Main Hall

This area has a battery operated smoke alarm.

Smoke alarms generally have a finite life cycle and this can depend on the manufacturer, however there were no visible expiry dates. Battery operated smoke alarms need to be tested on a monthly basis and hard-wired smoke alarms should be tested annually.

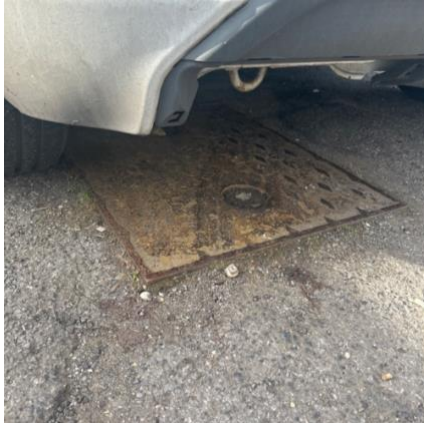
The property has an underground foul and storm drain with a plastic soil and vent pipe. This appeared to be functional when inspected but was not tested.

Inspection chambers are located to the front of the property.

Our inspection of the drainage system was limited to readily accessible chambers. The underground pipes could not be seen. The absence of any obvious problems does not necessarily mean that the concealed parts are free from defect. The drains will have inevitably deteriorated during the life of the building and it is possible that they are leaking or damaged.

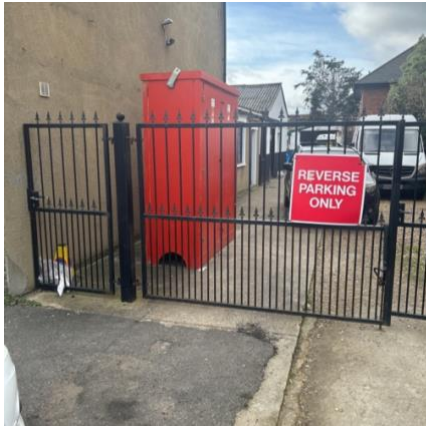
Landscape to right hand side.

Whilst there are some semi mature trees and shrubs within close proximity to the property, none are thought to pose a significant risk. Nevertheless, all trees and shrubs should be regularly maintained and pruned.
