LEVEL 3

Your survey report...

Contents

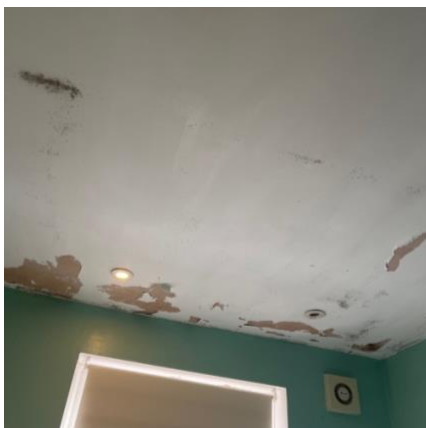
Bathroom

(Condition Rating 2)

The ceiling is poorly finished and would benefit from being taken down, plaster boarded and skimmed.

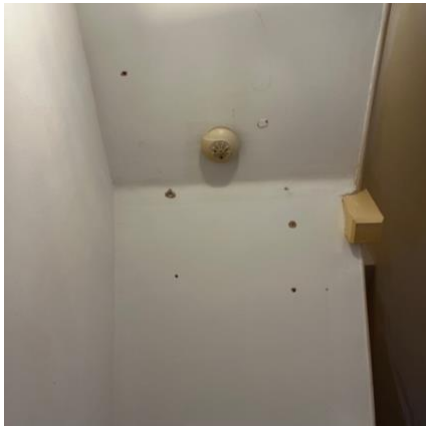
Hall

(Condition Rating 2)

The ceiling is poorly finished and would benefit from being skimmed.

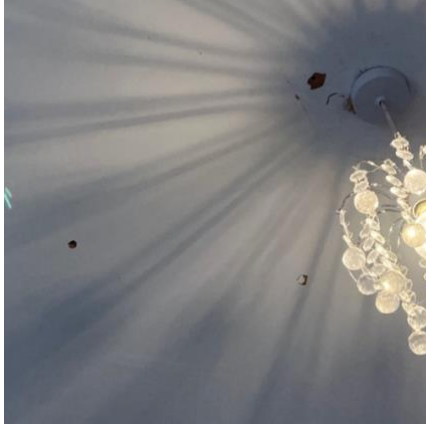
Dining Room

(Condition Rating 2)

The ceiling is poorly finished and would benefit from being skimmed.

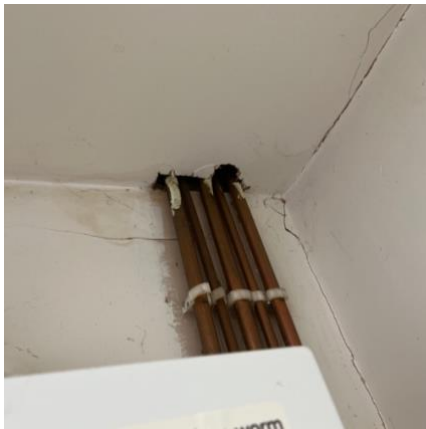
Utility

(Condition Rating 2)

The ceiling is poorly finished and would benefit from being taken down, plaster boarded and skimmed.

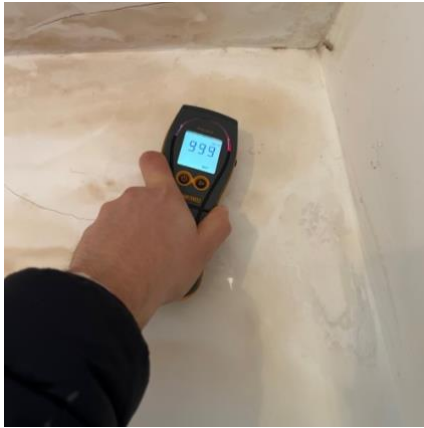
Bedroom 1

(Condition Rating 3)

Tests carried out to the right-hand side party wall with a damp meter revealed readings as per the attached photograph. This appeared to be caused by penetrating damp.

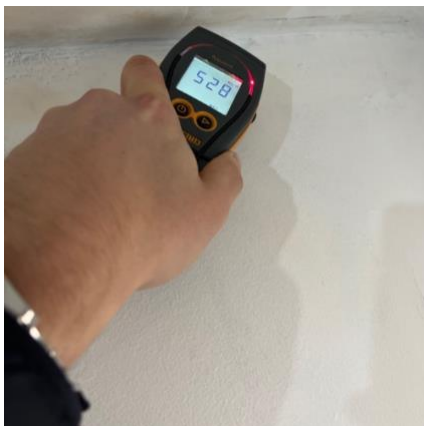
Bedroom 2

(Condition Rating 3)

Tests carried out to the left-hand side party wall with a damp meter revealed readings as per the attached photograph. This appeared to be caused by penetrating damp.

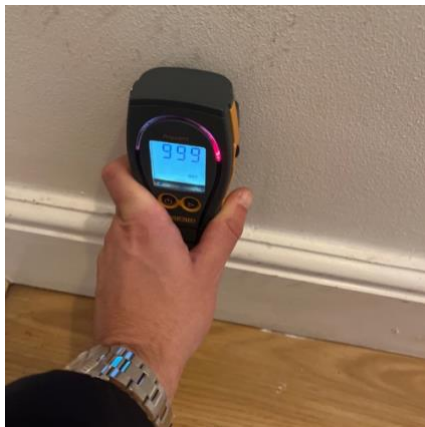
Hall

(Condition Rating 3)

Tests carried out to the dividing living room wall with a damp meter revealed readings as per the attached photograph.

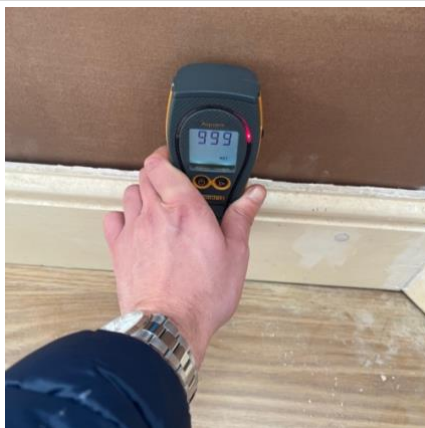
Living Room

(Condition Rating 3)

Tests carried out to the front external wall with a damp meter revealed readings as per the attached photograph.

A reading above 20% relative moisture level is a cause for concern and is likely caused by rising damp. Rising damp may require a chemical damp proof course injection. Note: there may be further defects including wet rot under the floor as a result of the damp and further investigation is recommended.

Cost of associated remedial work detailed in Section B, R48

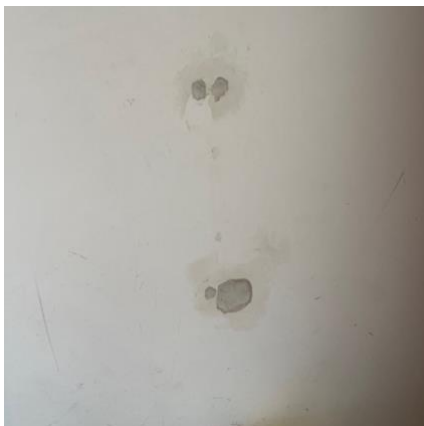
(Condition Rating 2)

There is a poorly plastered area that would benefit from being re-plastered.

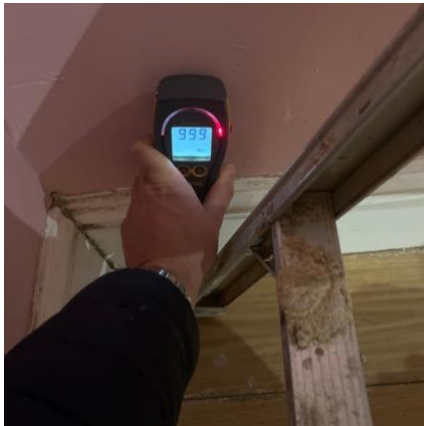
Kitchen

(Condition Rating 3)

Tests carried out to all walls with a damp meter revealed readings as per the attached photograph.

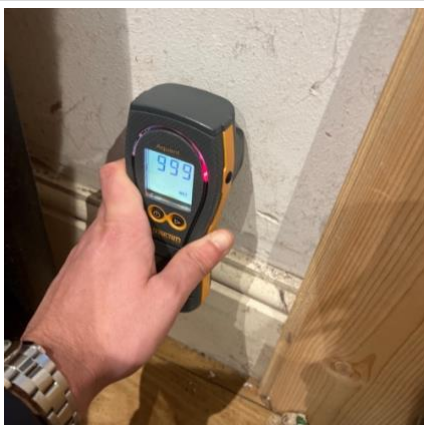
Utility

(Condition Rating 3)

Tests carried out to the external wall with a damp meter revealed readings as per the attached photograph.

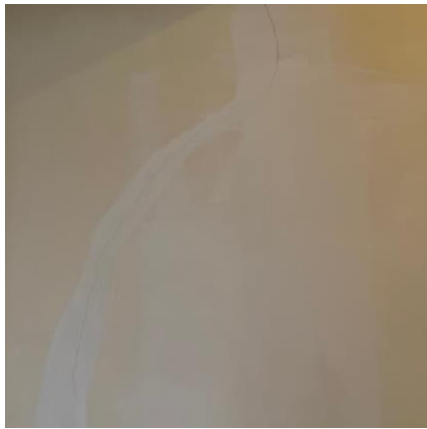
Landing

(Condition Rating 2)

There is defective plaster that would benefit from being re-plastered.

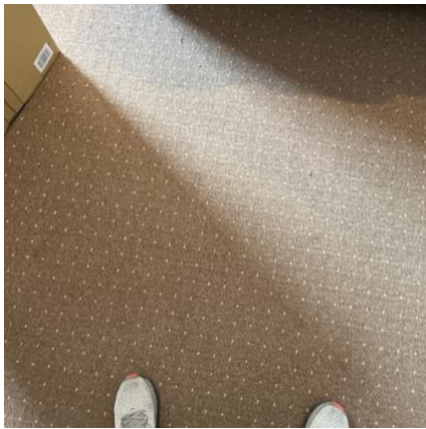
Bedroom 1

(Condition Rating 2)

The floor would benefit from having the floorboards secured once floor coverings have been removed as there are loose floorboards resulting in creaking floors. This may simply be the result of poor workmanship.

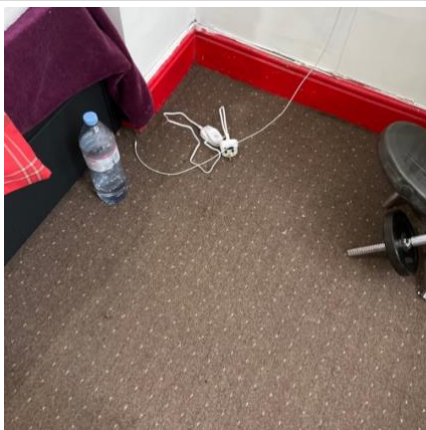
Bedroom 2

(Condition Rating 2)

The floor would benefit from having the floorboards secured once floor coverings have been removed as there are loose floorboards resulting in creaking floors. This may simply be the result of poor workmanship.

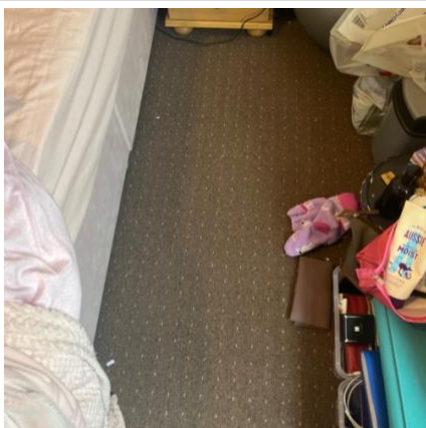
Bedroom 3

(Condition Rating 2)

The floor would benefit from having the floorboards secured once floor coverings have been removed as there are loose floorboards resulting in creaking floors. This may simply be the result of poor workmanship.

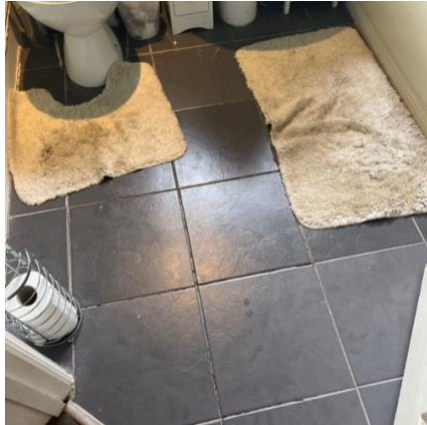
Bathroom

(Condition Rating 2)

The floor would benefit from having the floorboards secured once floor coverings have been removed as there are loose floorboards resulting in creaking floors. This may simply be the result of poor workmanship.

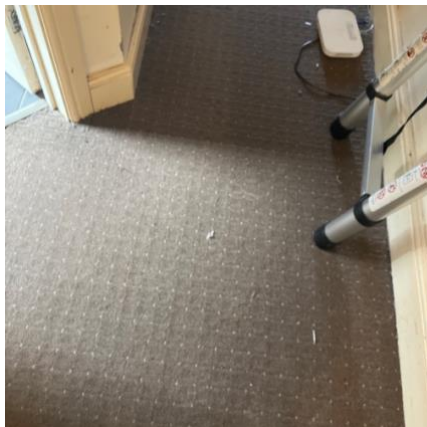
Landing

(Condition Rating 2)

The floor would benefit from having the floorboards secured once floor coverings have been removed as there are loose floorboards resulting in creaking floors. This may simply be the result of poor workmanship.

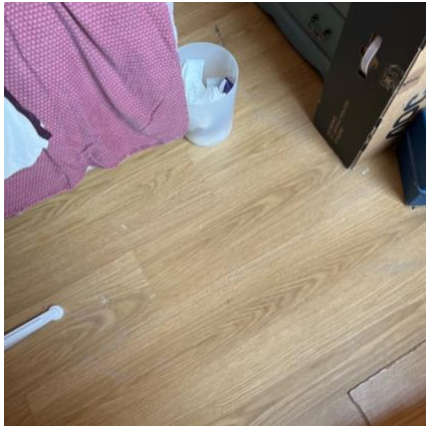
Dining Room

(Condition Rating 2)

The floor would benefit from having the floorboards secured once floor coverings have been removed as there are loose floorboards resulting in creaking floors. This may simply be the result of poor workmanship.

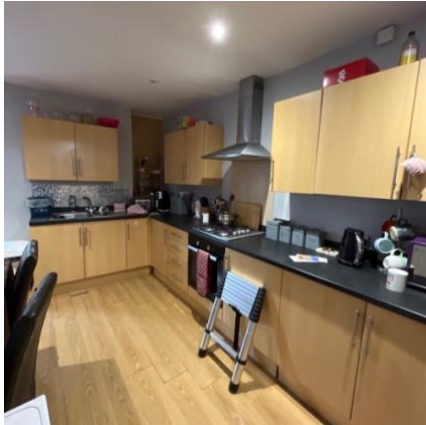
Kitchen

(Condition Rating 2)

The kitchen is in tired condition and full refurbishment is recommended.

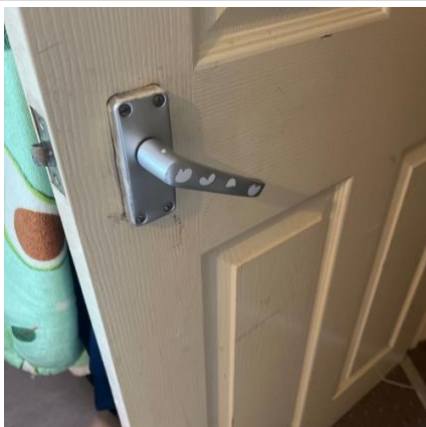
Bedroom 3

(Condition Rating 2)

The door furniture is faulty.

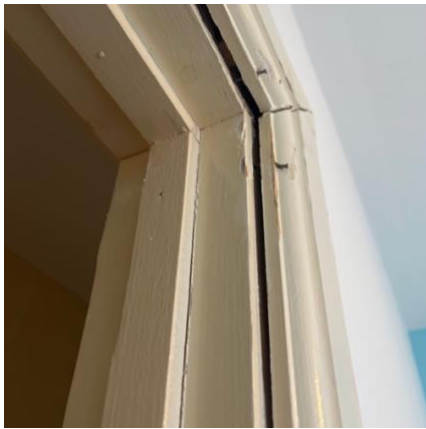
Bedroom 4

(Condition Rating 2)

Poorly fitted door and in poor condition.

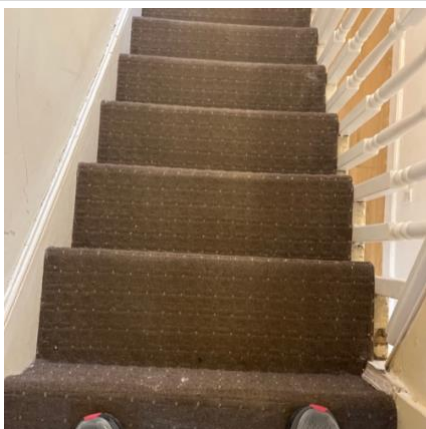
(Condition Rating 2)

The staircase has loose treads.

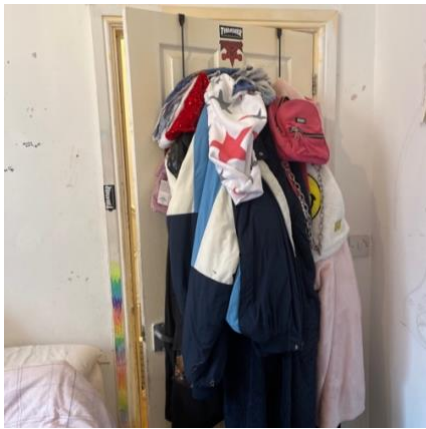
Dining Room

(Condition Rating 2)

The door does not close correctly and needs to be eased and adjusted.

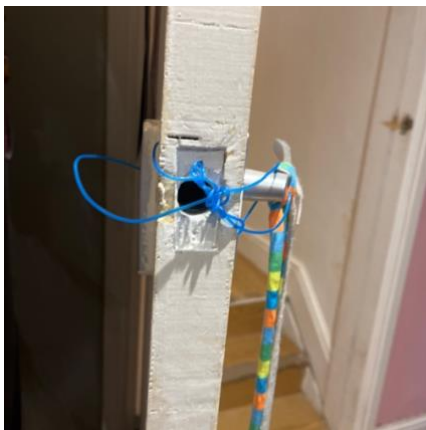
Kitchen

(Condition Rating 2)

Poorly fitted door and in poor condition.

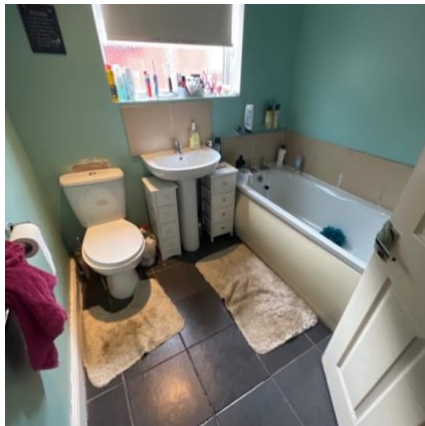
Bathroom

(Condition Rating 2)

This bathroom would benefit from complete refurbishment.

Cost of associated remedial work detailed in Section B, R3

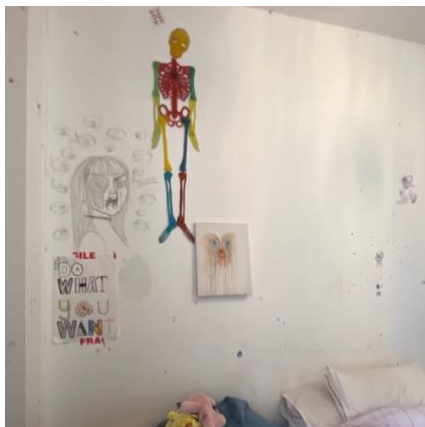
E9 Other

(Condition Rating 2)

This property would benefit from internal decorations.

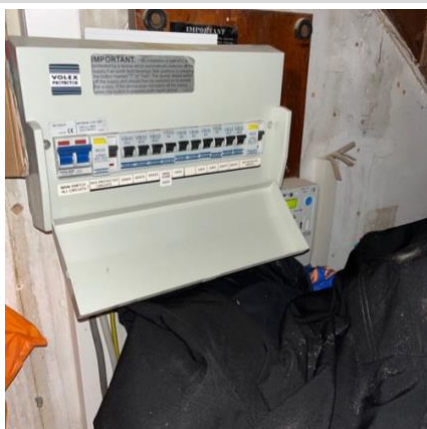
F1 Electricity

There is a mains supply and the electricity was on when we inspected. The consumer board and the electricity meter are located in the cupboard under the stairs. The consumer unit is a relatively modern unit with miniature circuit breakers and RCDs.

There was no up to date Electrical Installation Condition Report for the electrics at the time of inspection and therefore a Condition Rating 3 has been applied.

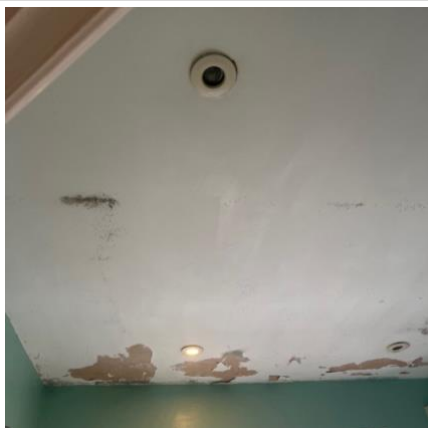
Bathroom

(Condition Rating 2)

Light fitting not working, but may be a blown bulb.

Cost of associated remedial work detailed in Section B, R4

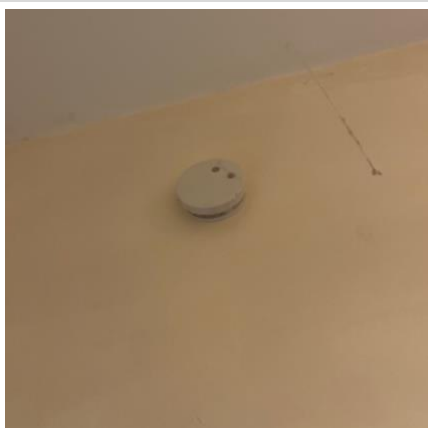
Landing

This area has a battery-operated smoke alarm.

Smoke alarms generally have a finite life cycle and this can depend on the manufacturer, however there were no visible expiry dates. Battery operated smoke alarms need to be tested on a monthly basis and hard-wired smoke alarms should be tested annually.

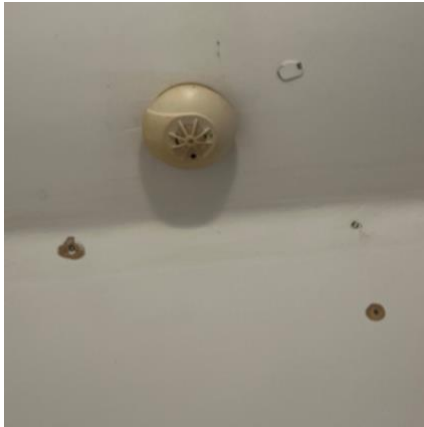
Hall

This area has a battery-operated smoke alarm.

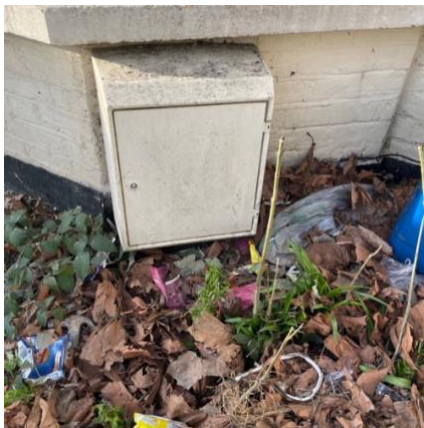
F2 Gas/oil

There is a mains gas supply to the property. The gas meter is located in a plastic housing externally.

There was no up to date Gas Safe certificate visible at the time of inspection and therefore a Condition Rating 3 has been applied.

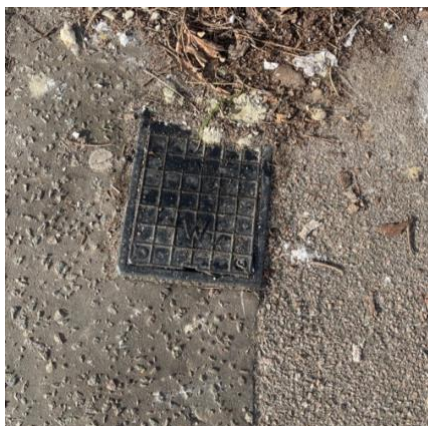
F3 Water

There is a mains water supply to the property. The main stopcock and the water meter are located on the front path.

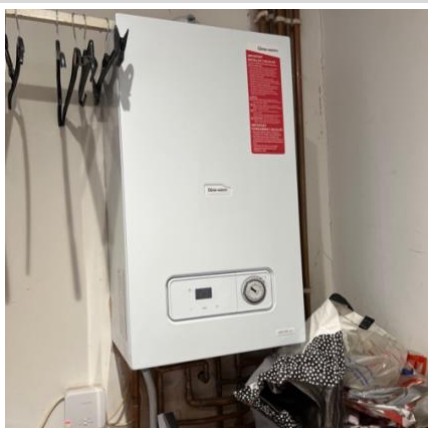
F4 Heating

The Glow worm gas fired, combination boiler in the utility room provides central heating throughout the accommodation. The central heating system was in operation at the time of inspection. The heating system has a fixed wall programmer. The flue for the boiler exits through the rear. This property benefits from a variety of single and double panel radiators.

There was no up to date Gas Safe certificate visible at the time of inspection and therefore a Condition Rating 3 has been applied.

We recommend that you establish the service history of the system prior to your commitment to purchase the property as only regular servicing by a competent person can ensure its future efficiency and safety. If your enquiries indicate that previous maintenance has been inadequate, then the whole system should be checked by a competent engineer prior to purchase.

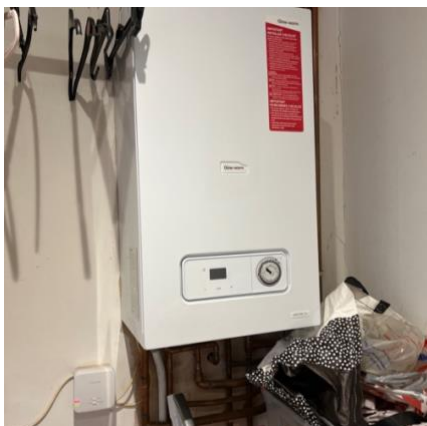
F5 Water heating

The Glow worm gas-fired boiler also provides hot water. There is no hot water storage cylinder. Hot water is provided directly to water outlets on demand by heating water directly from the mains supply.

There was no up to date Gas Safe certificate visible at the time of inspection and therefore a Condition Rating 3 has been applied.

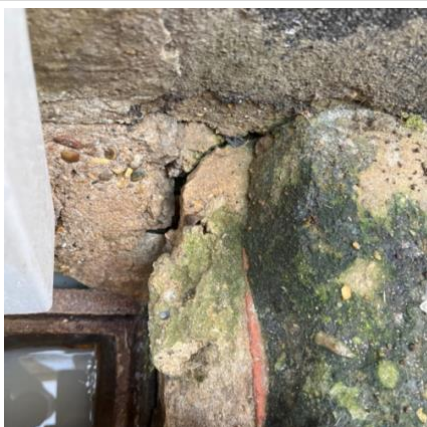
(Condition Rating 3)

The flaunching to the gully is in poor condition and could potentially allow discharging rainwater to penetrate the foundations of the building. We recommend this is repaired.

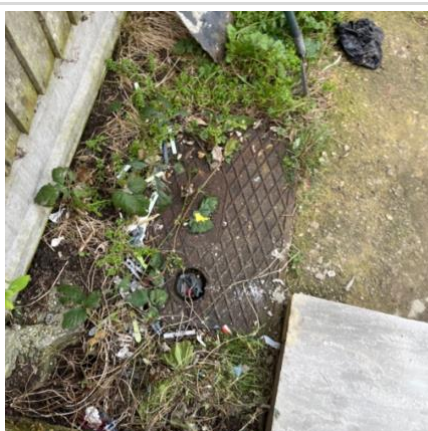
Inspection chambers are located to the rear of the property. No blockages were visible at time of inspection.

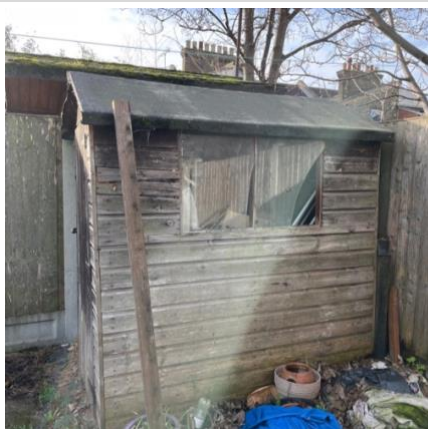
G2 Permanent outbuildings and other structures

(Condition Rating 2)

The outbuilding is in poor condition and we recommend this is demolished.

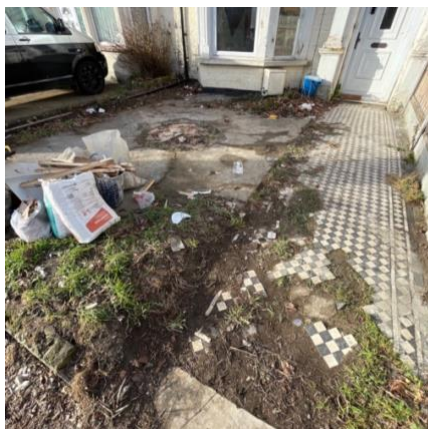
Landscape to front.

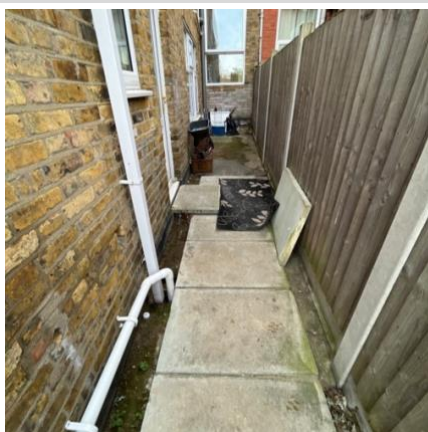
Landscape to rear.

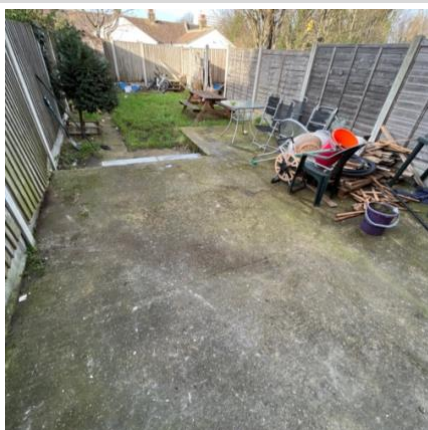
Landscape to rear.

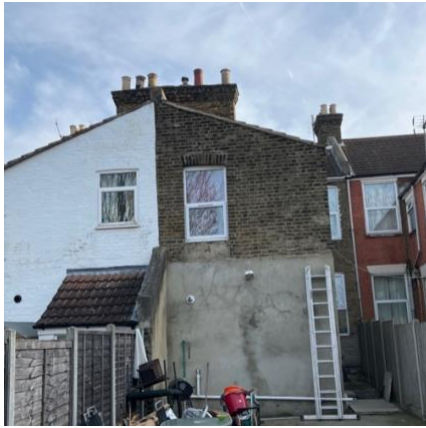
Rear elevation.

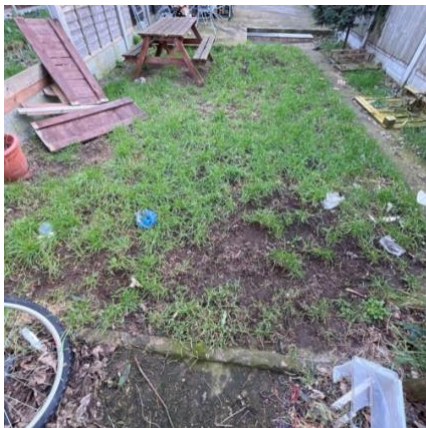
(Condition Rating 2)

The hardstandings to the front and rear are uneven and need to be re-landscaped.
