RICS Building Survey...

Clients name
Date of inspection 02 April 2019

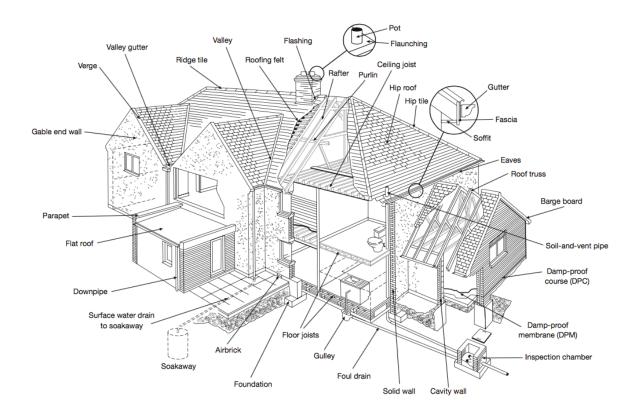
Typical house diagram

This diagram illustrates where you may find some of the building elements referred to in the report.
